## **Sediment Management Plan McTaggart's Pond Dam Fitchburg, MA**

**To:** Mr. Lenny Laakso, P.E. – Commissioner of Public Works, Fitchburg, MA  
**FROM:** Jason M. Perry, Sr. Env. Scientist; Daniel R. Buttrick, P.E., Sr. Engineer  
**DATE:** October 8, 2019

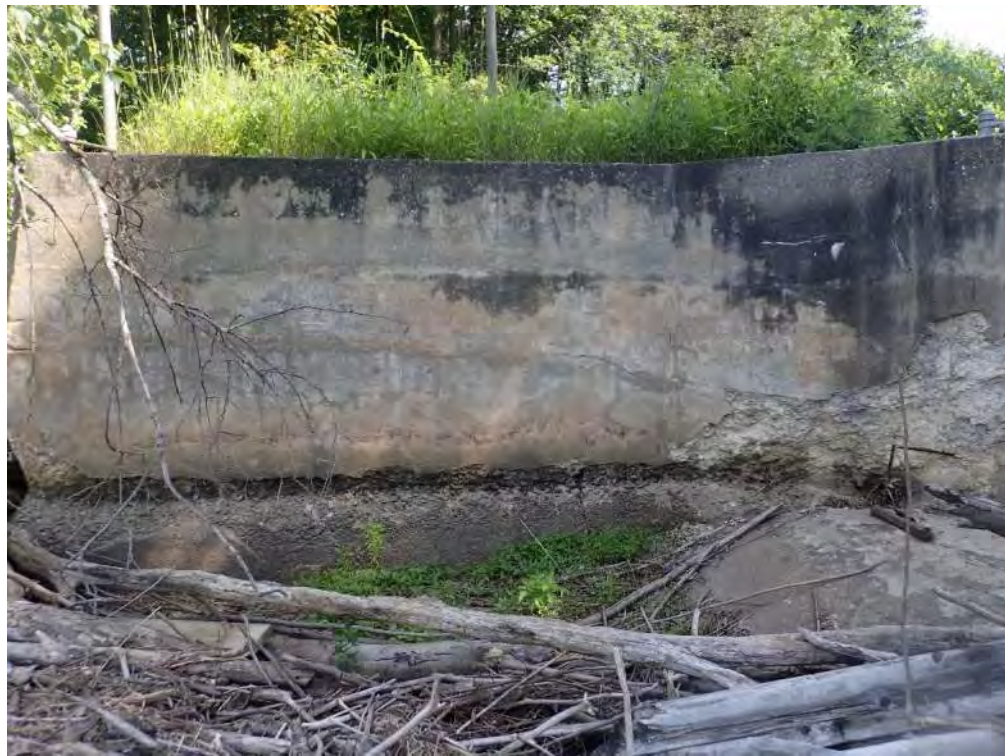
**Photo 12 – Overview of left spillway training wall (7/10/2019); note deterioration along waterline**

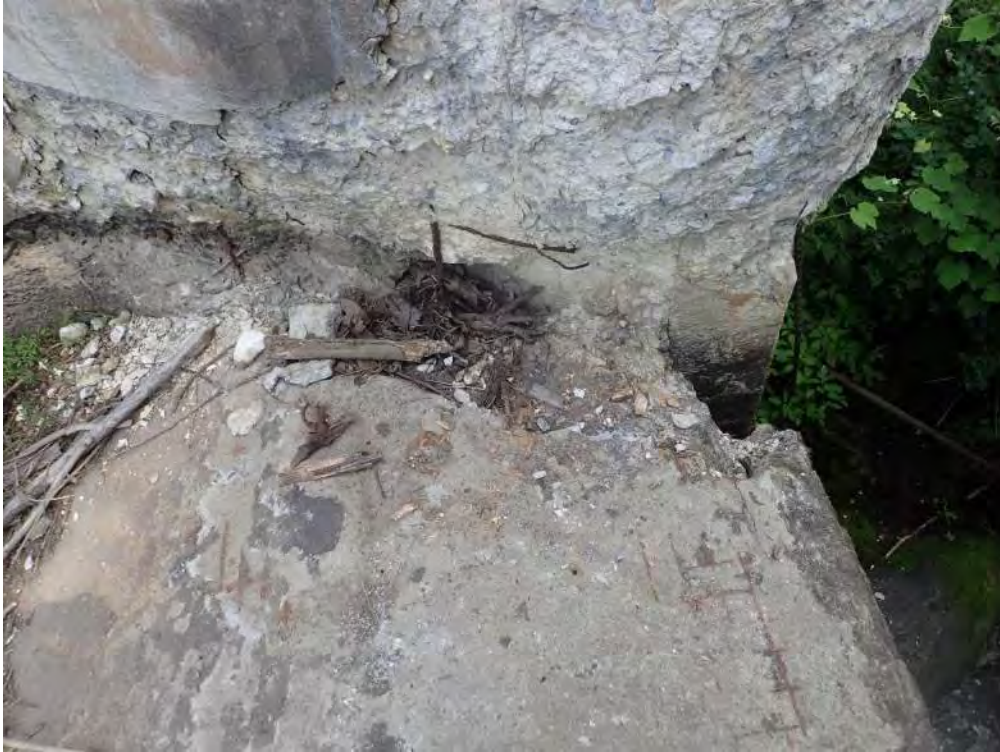
**Photo 13 – Deteriorated area at left training wall – spillway interface (7/10/2018)**

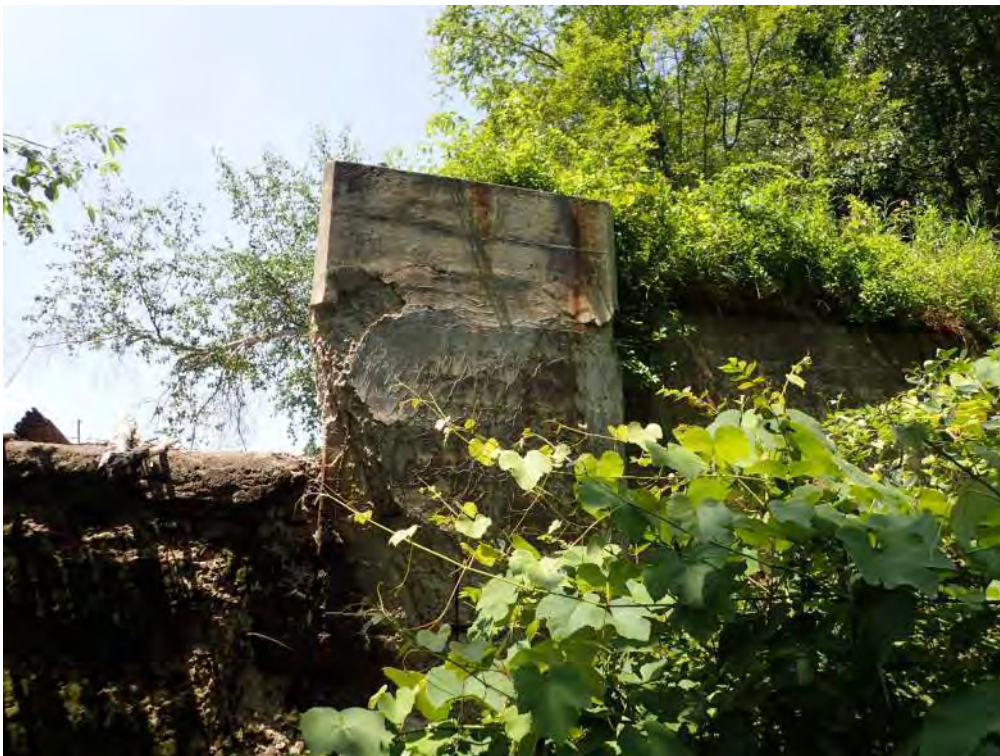
**Photo 14 – Overview of downstream left wall (7/10/2019); note spalls and loose concrete materials**

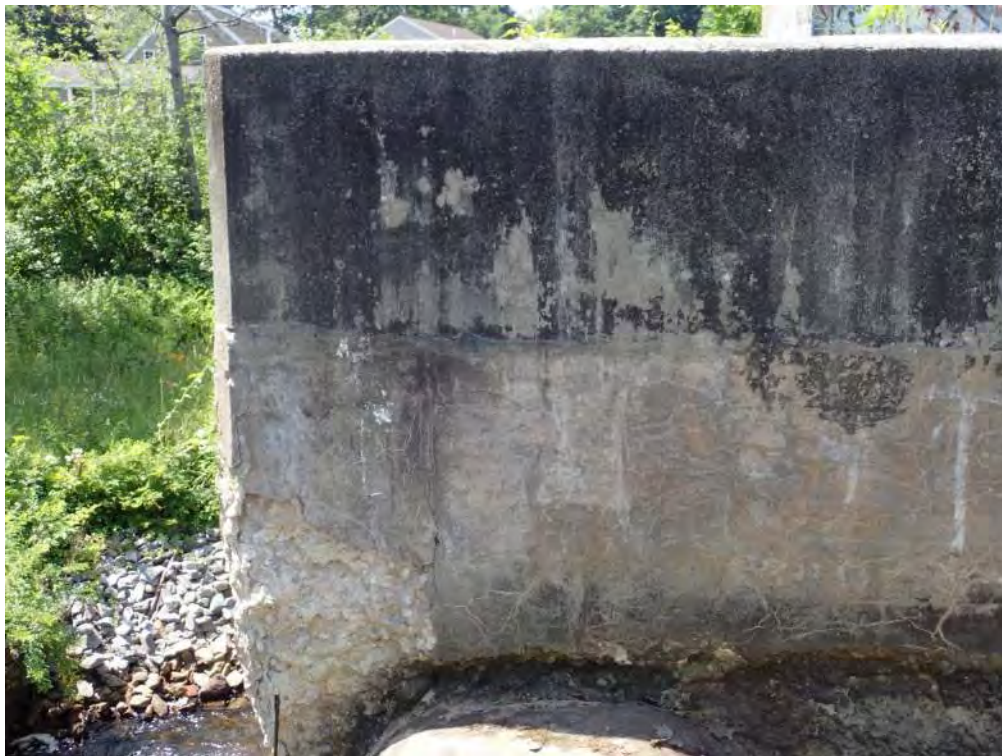
**Photo 20 – Downstream side of right training wall (7/10/2019); note deterioration at waterline and large spall at downstream end**

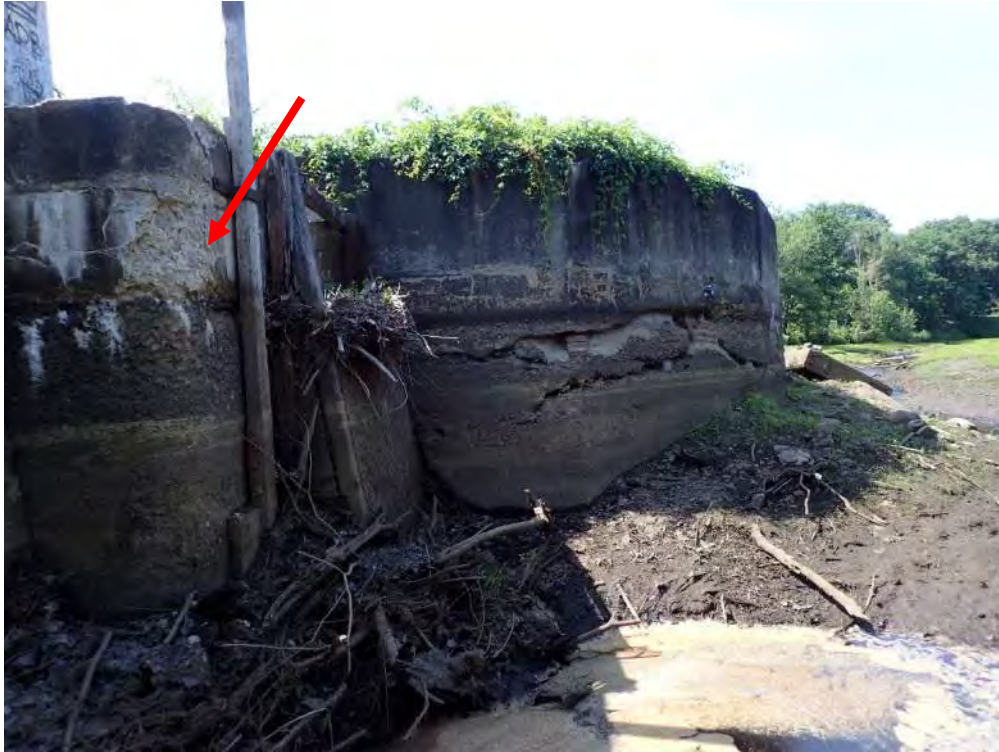
**Photo 21 – Overview of outlet structure and upstream wall (7/10/2019); note irregular spalls; area of concrete breakdown indicated with arrow**

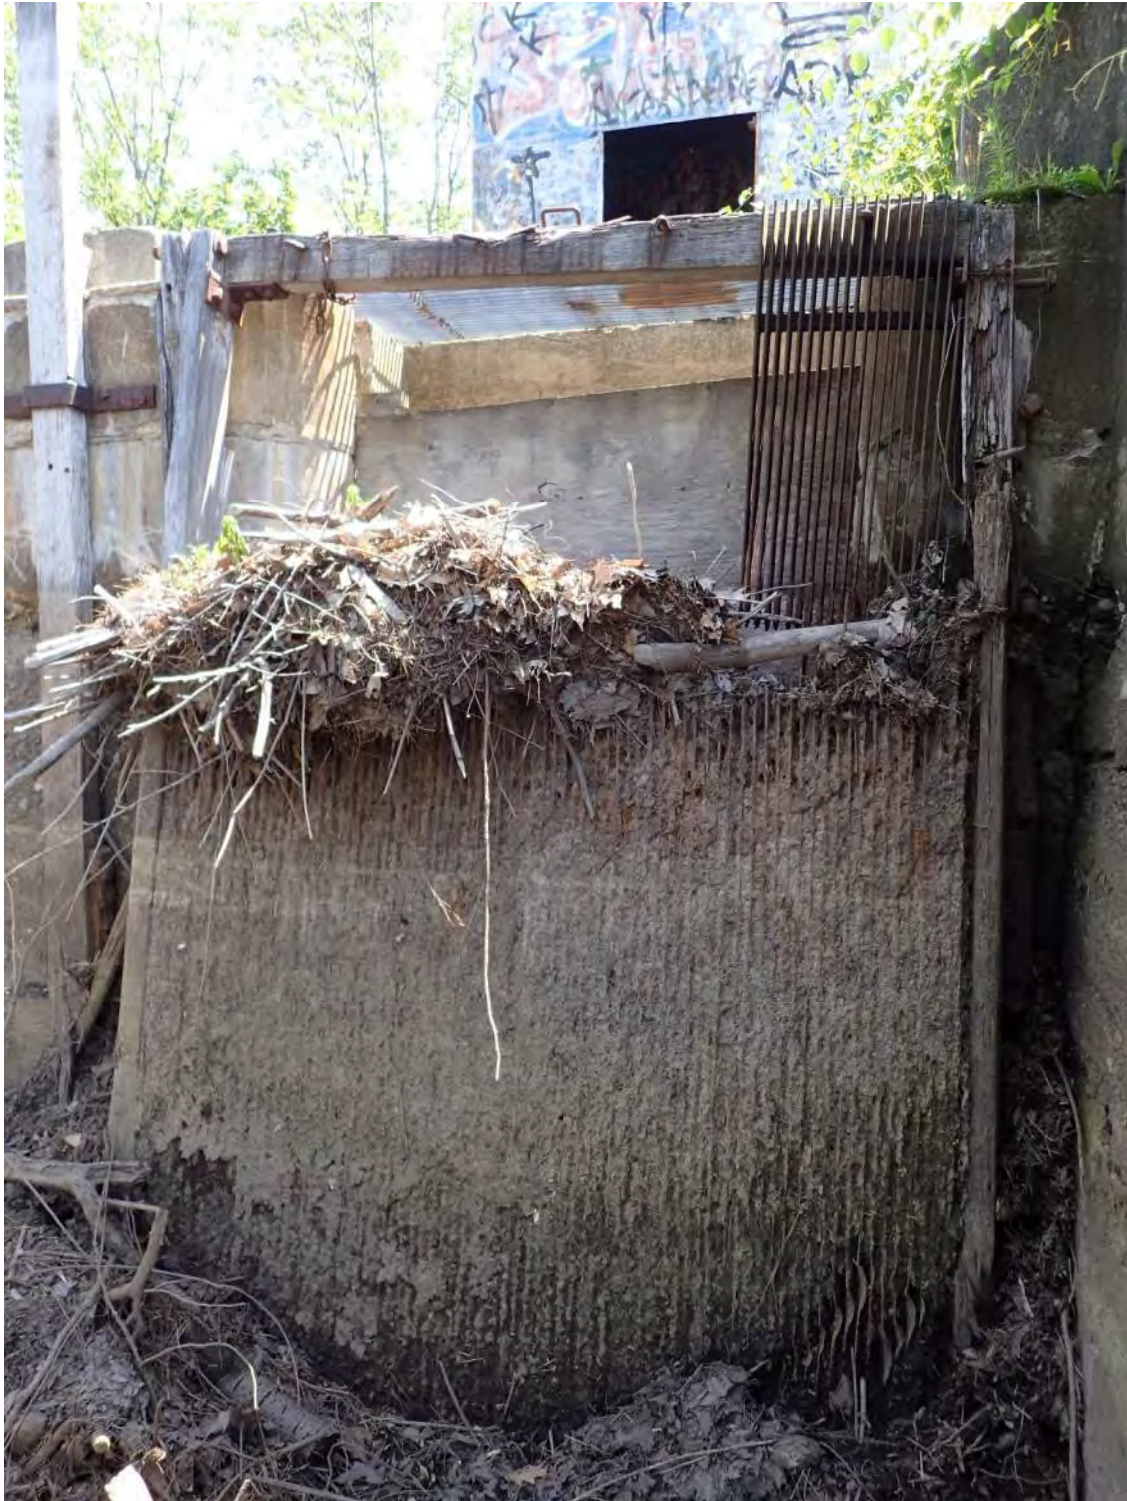
**Photo 23 – Deteriorated trash racks (7/10/2019)**

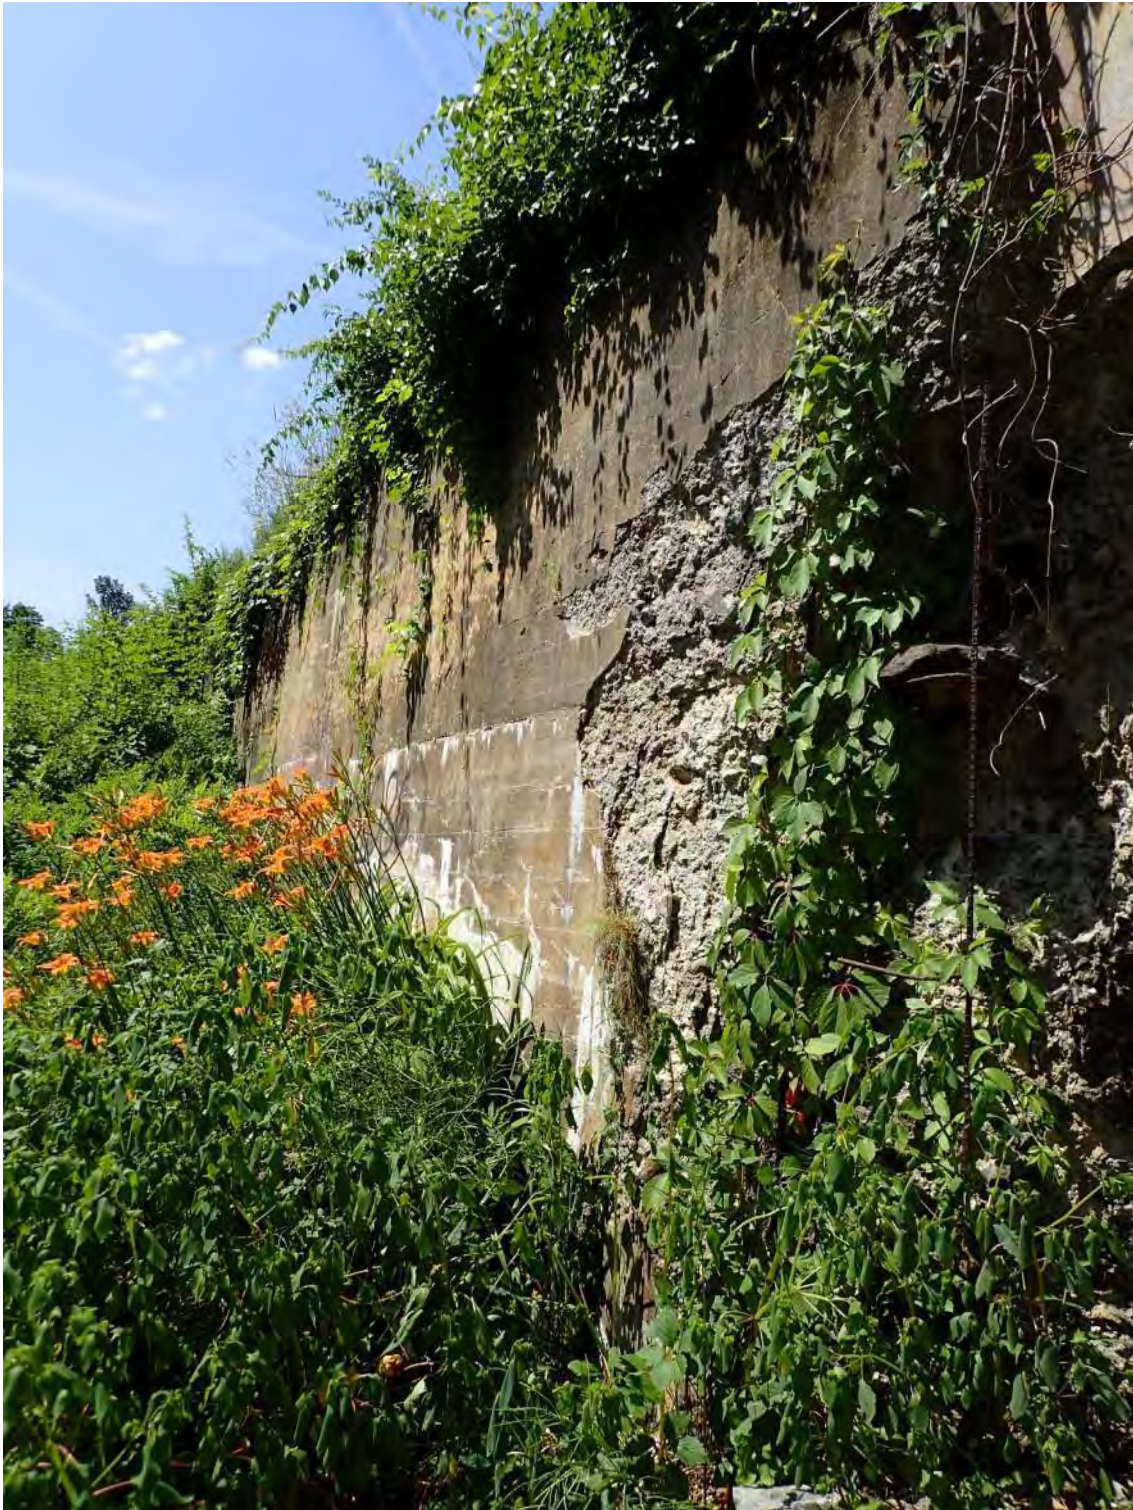
**Photo 26 – Right downstream wall ; note large spall with exposed rebar  
(7/10/2019)**

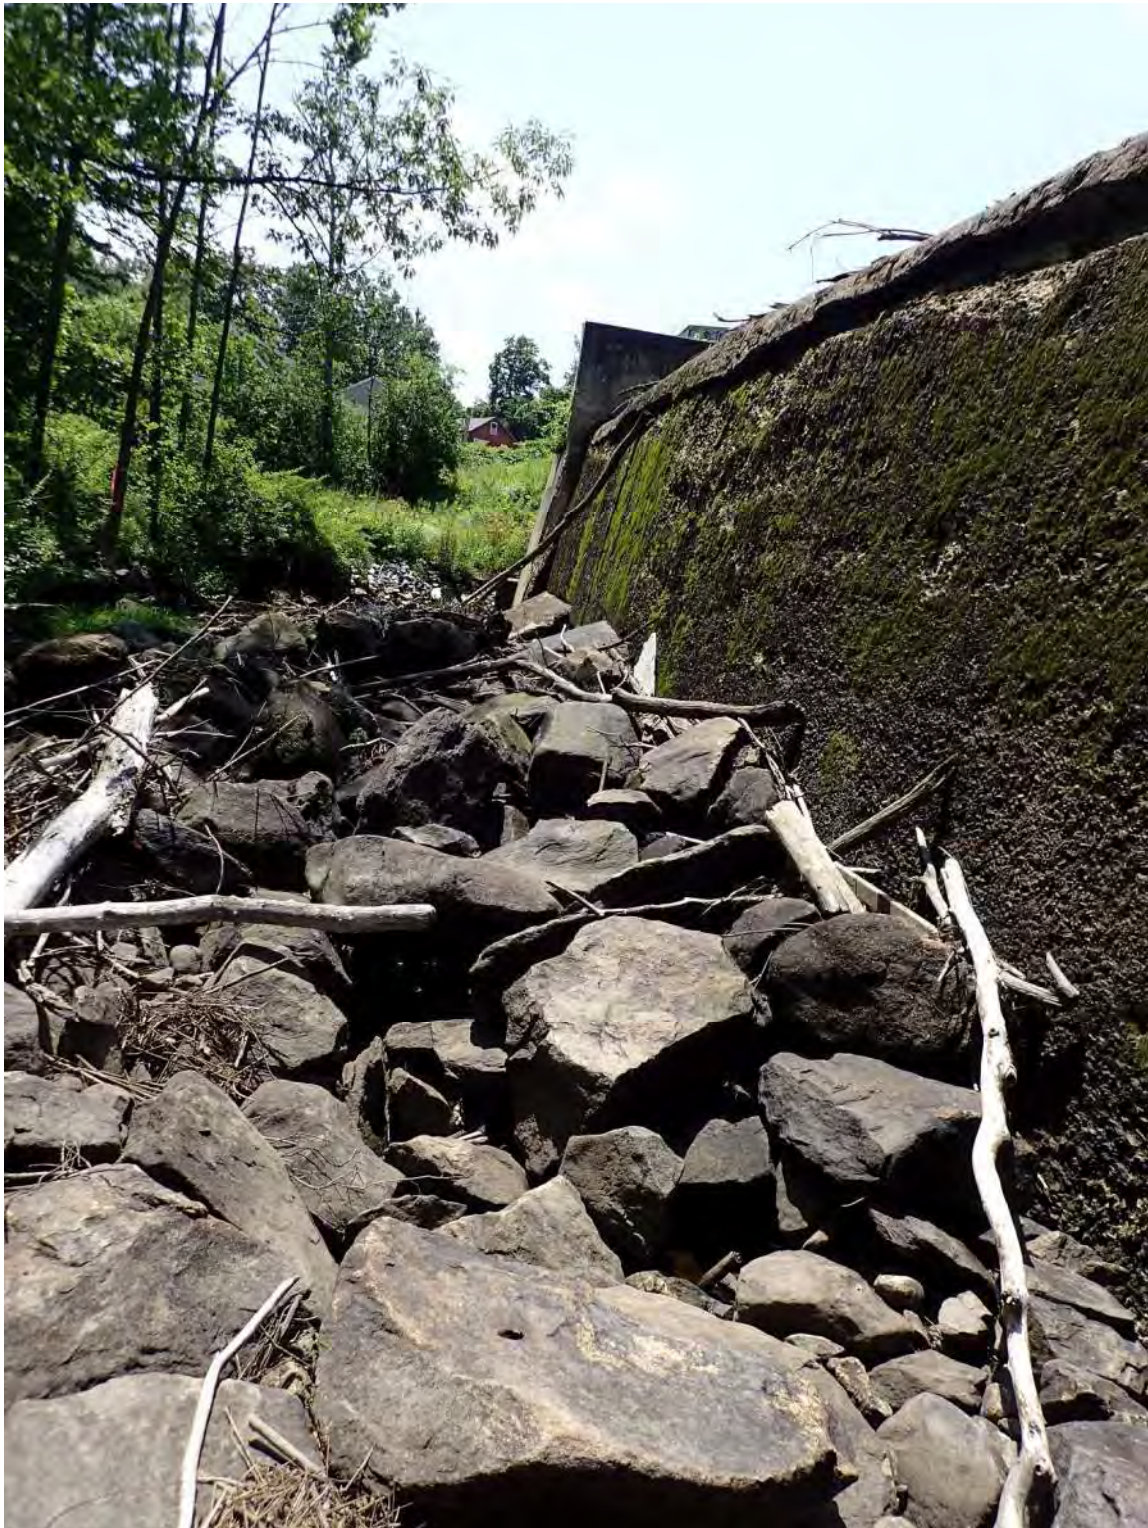
**Photo 29 – Right portion of spillway looking right; note wear on face and gap at crest (7/10/2019)**

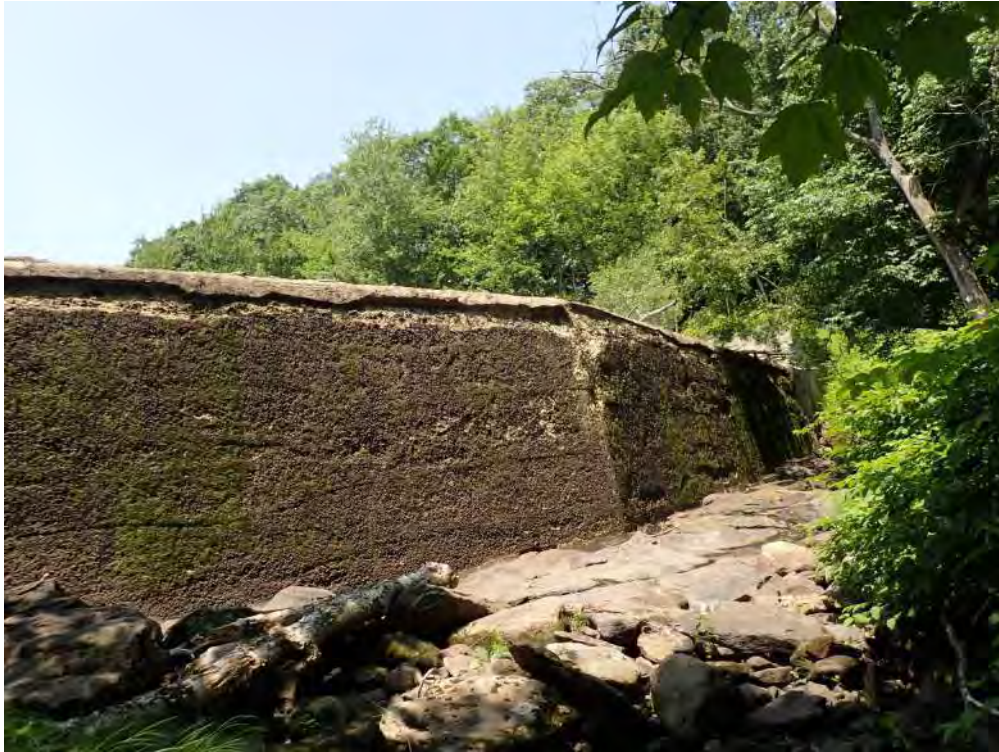
**Photo 30 – Center portion of downstream face of spillway looking left; note wear on face and gap at crest (7/10/2019)**

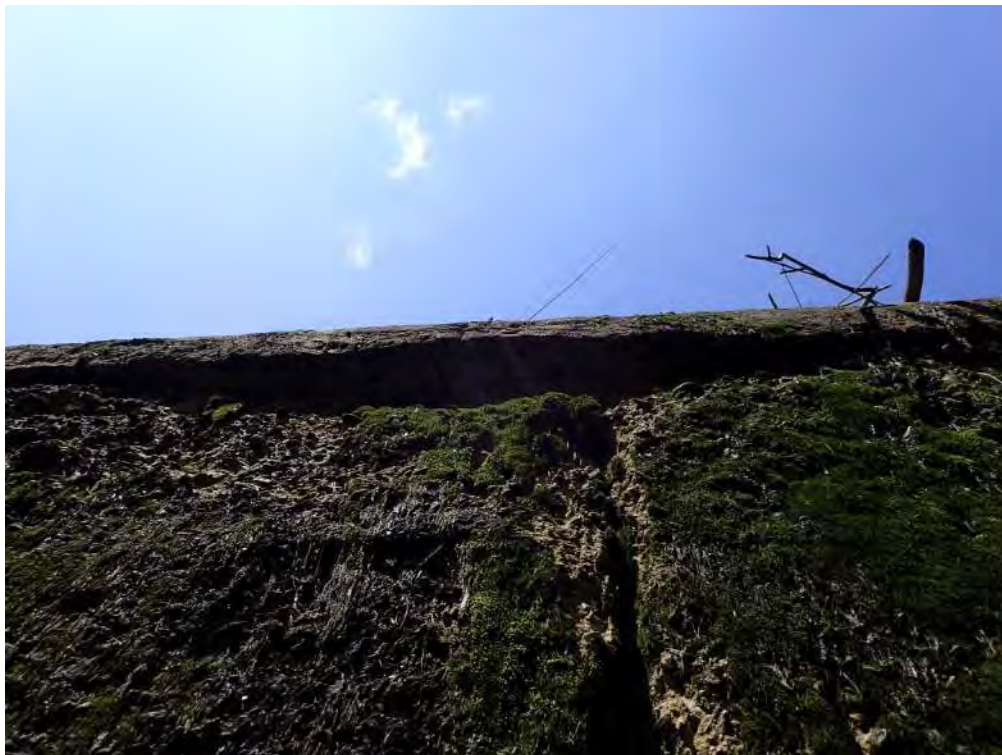
**Photo 31 – Gap below crest of spillway and wear at apparent joint (7/10/2019)**

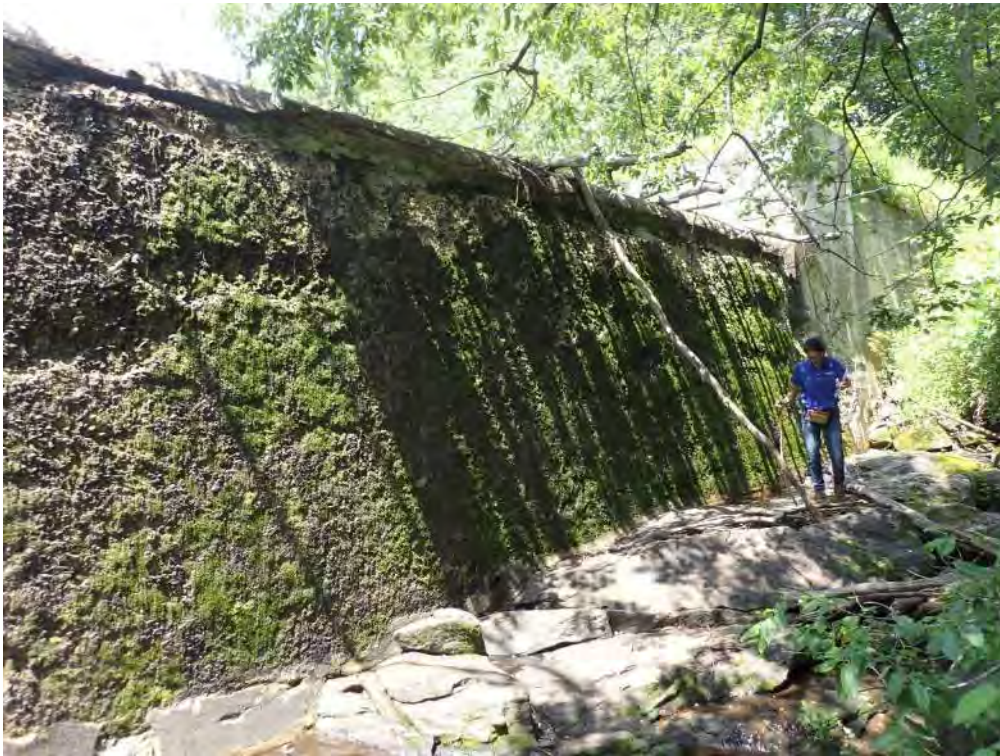
**Photo 33 – Left portion of downstream face of spillway looking left; note wear on face and gap at crest (7/10/2019)**

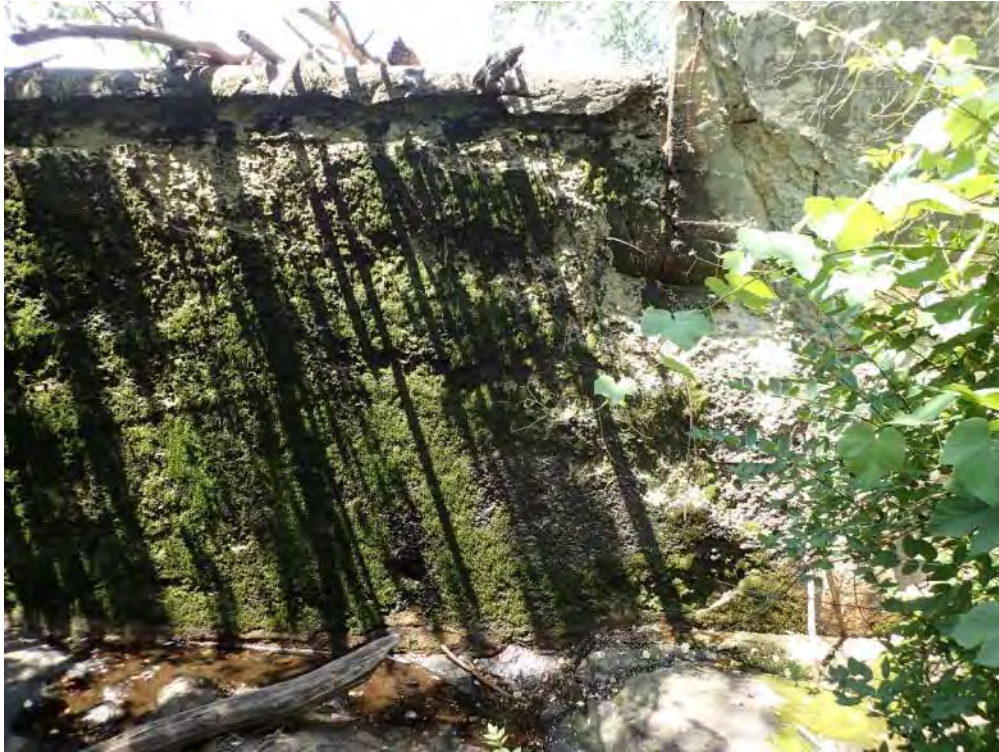
**Photo 34 – Downstream face of spillway at right training wall; note large spall and heavy wear (7/10/2019)**

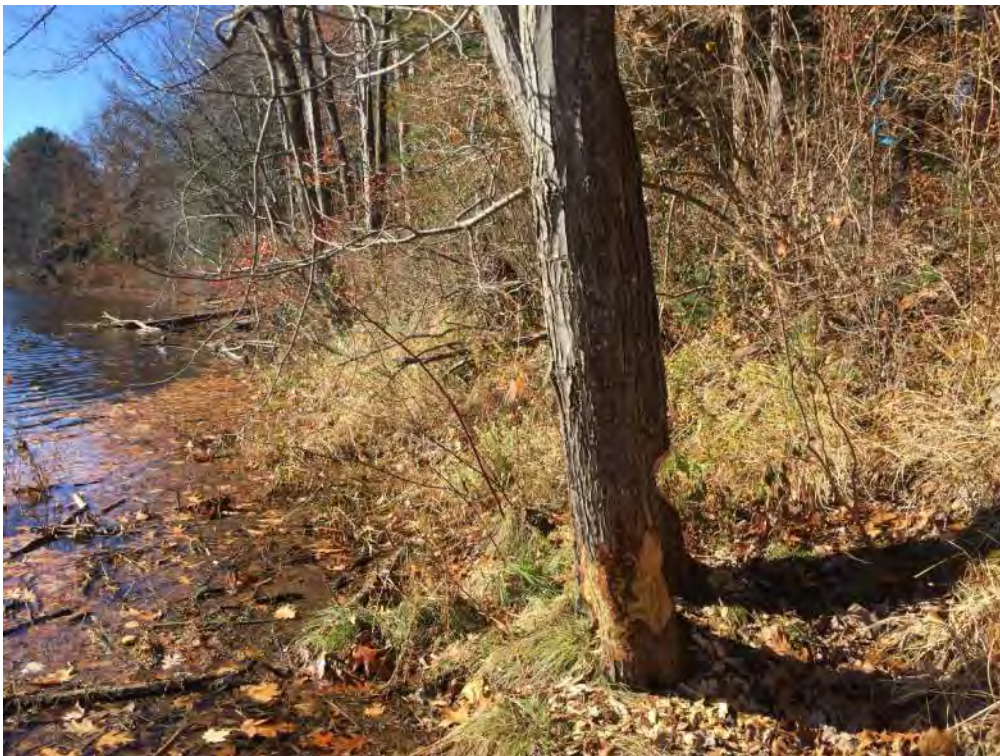
**Photo 37 – Northerly shore of pond; note signs of beaver activity (11/8/2018)**
