APPENDIX F  
**Geotechnical Memorandum**

## McTaggart's Pond Dam Seepage and Stability Evaluation

TO: Dan Buttrick  
FROM: Dan Gnatek  
COPY: File  
DATE: November 4, 2019

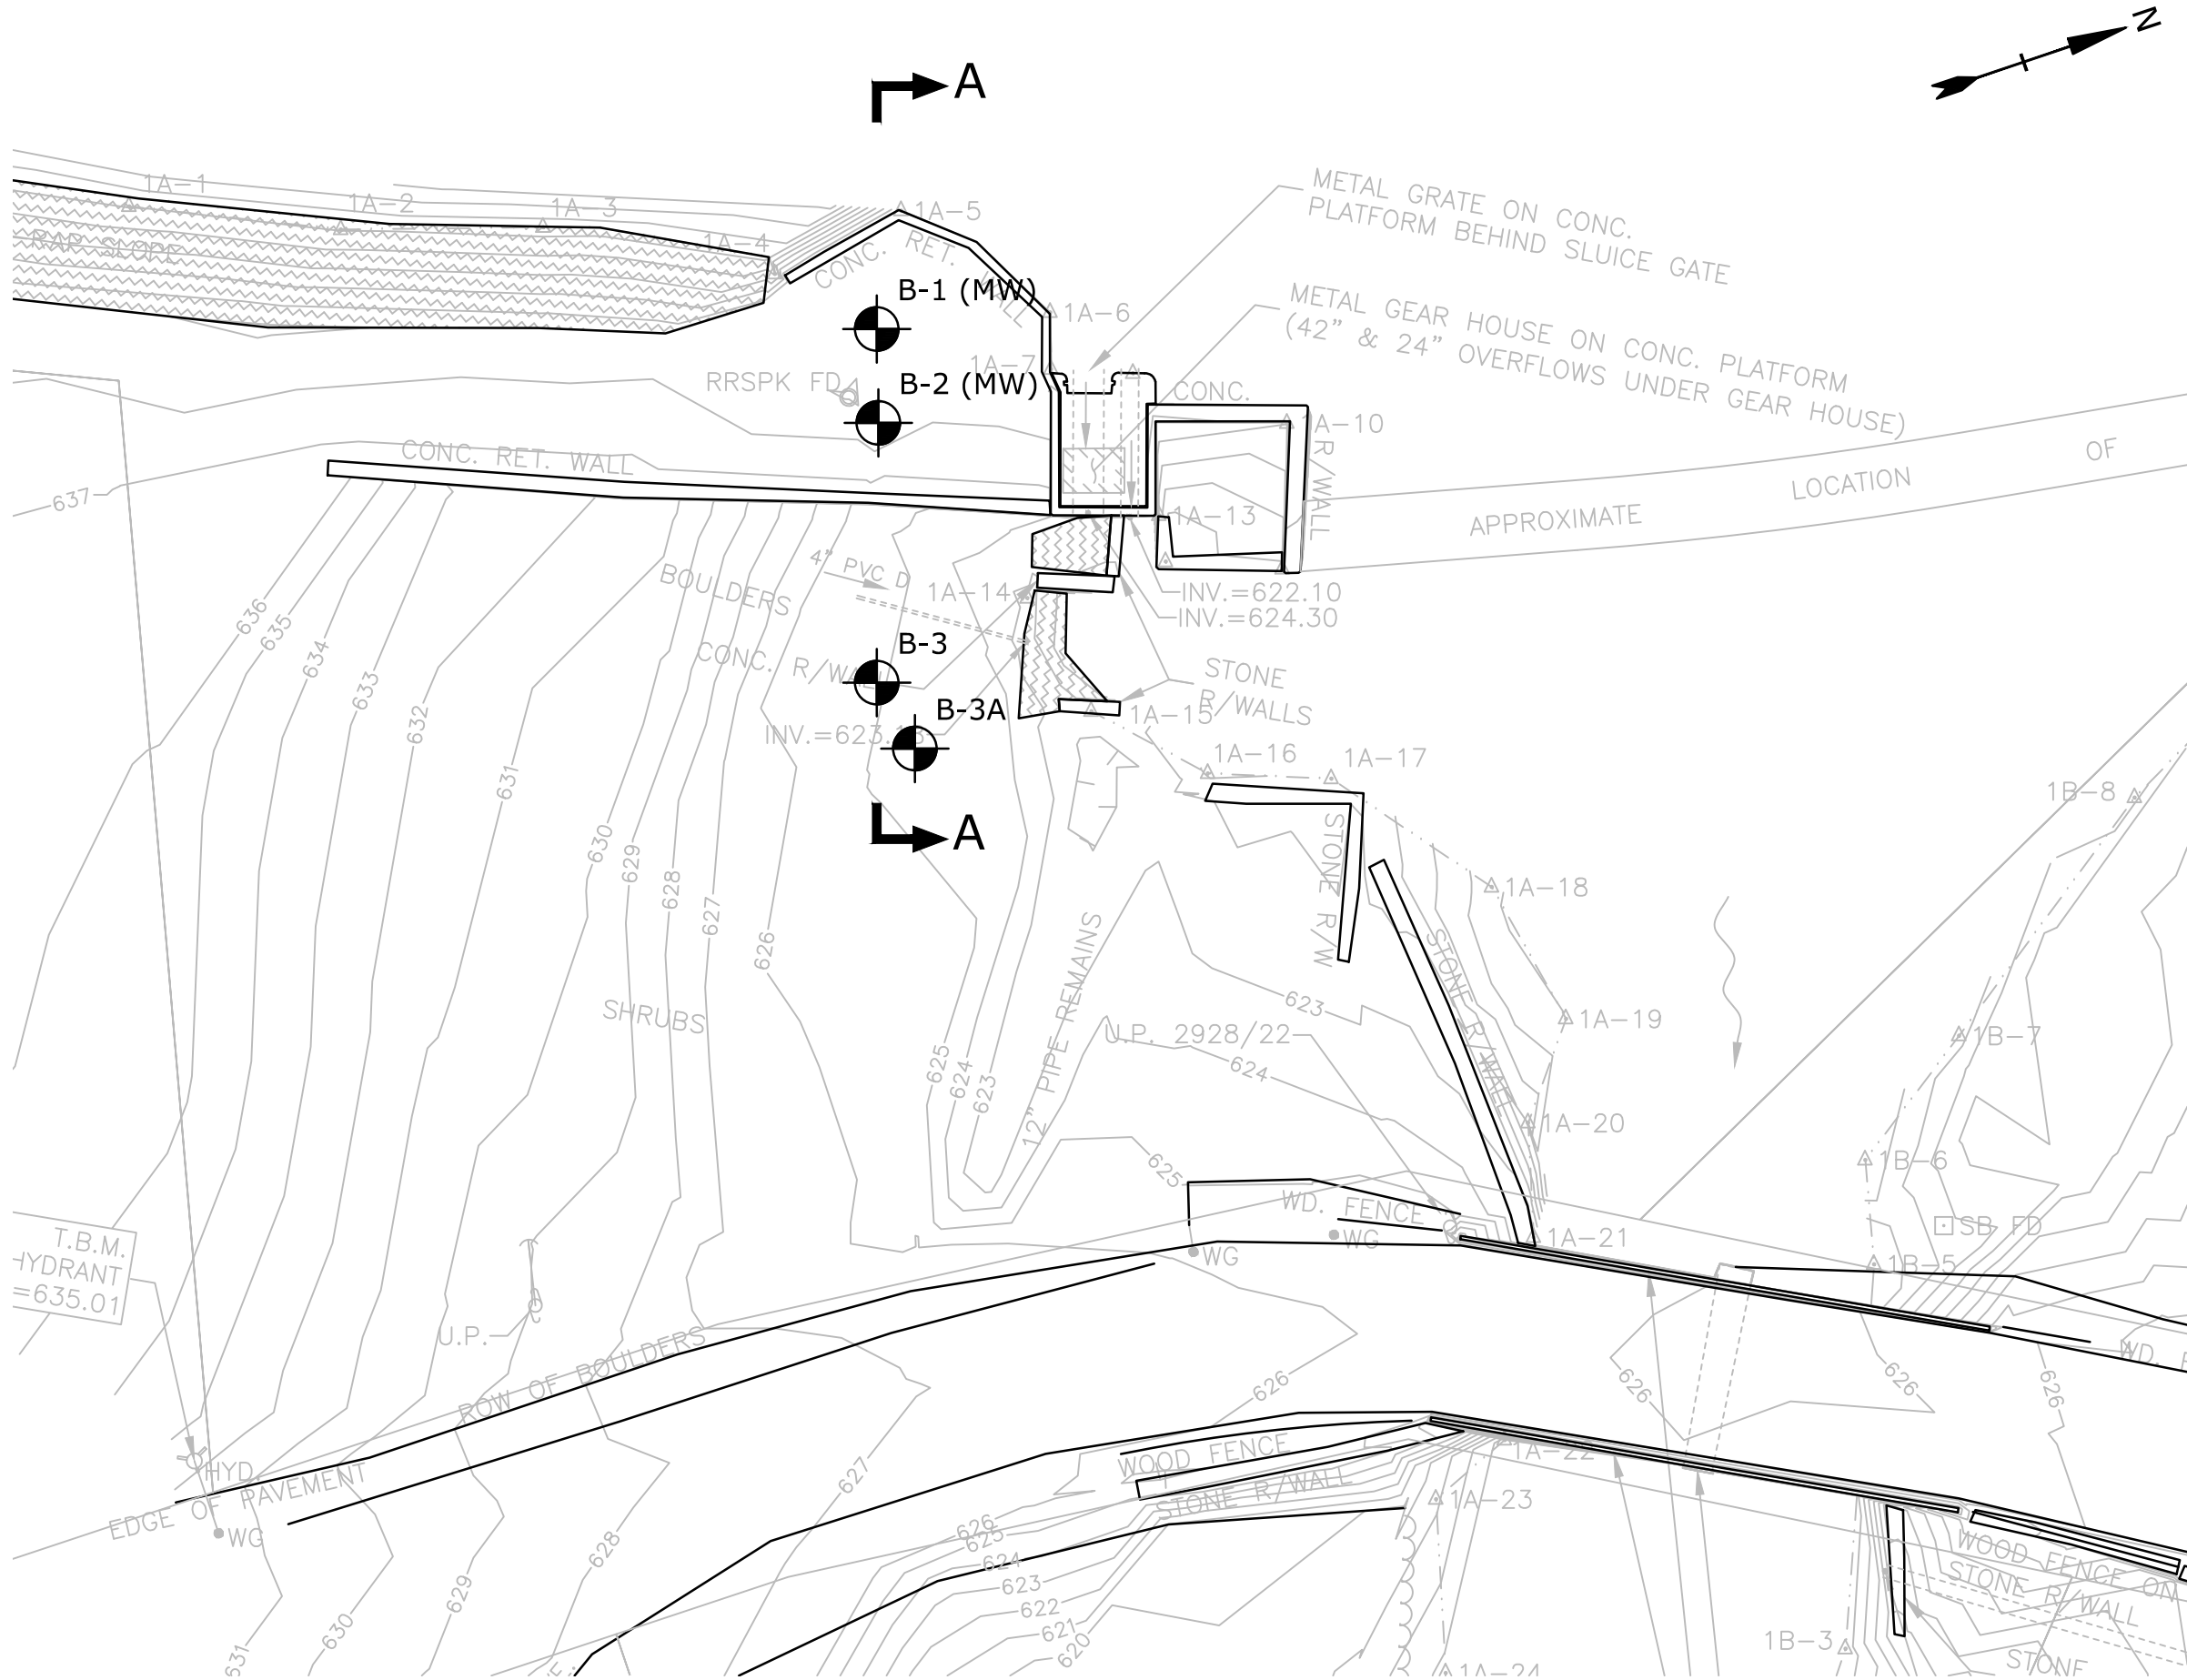
DATE: 02/07/2019  
SCALE: 1" = 20'  
FIGURE 2

Boring locations are shown on Figure 2, of Appendix A. Test boring logs are included in Appendix C.

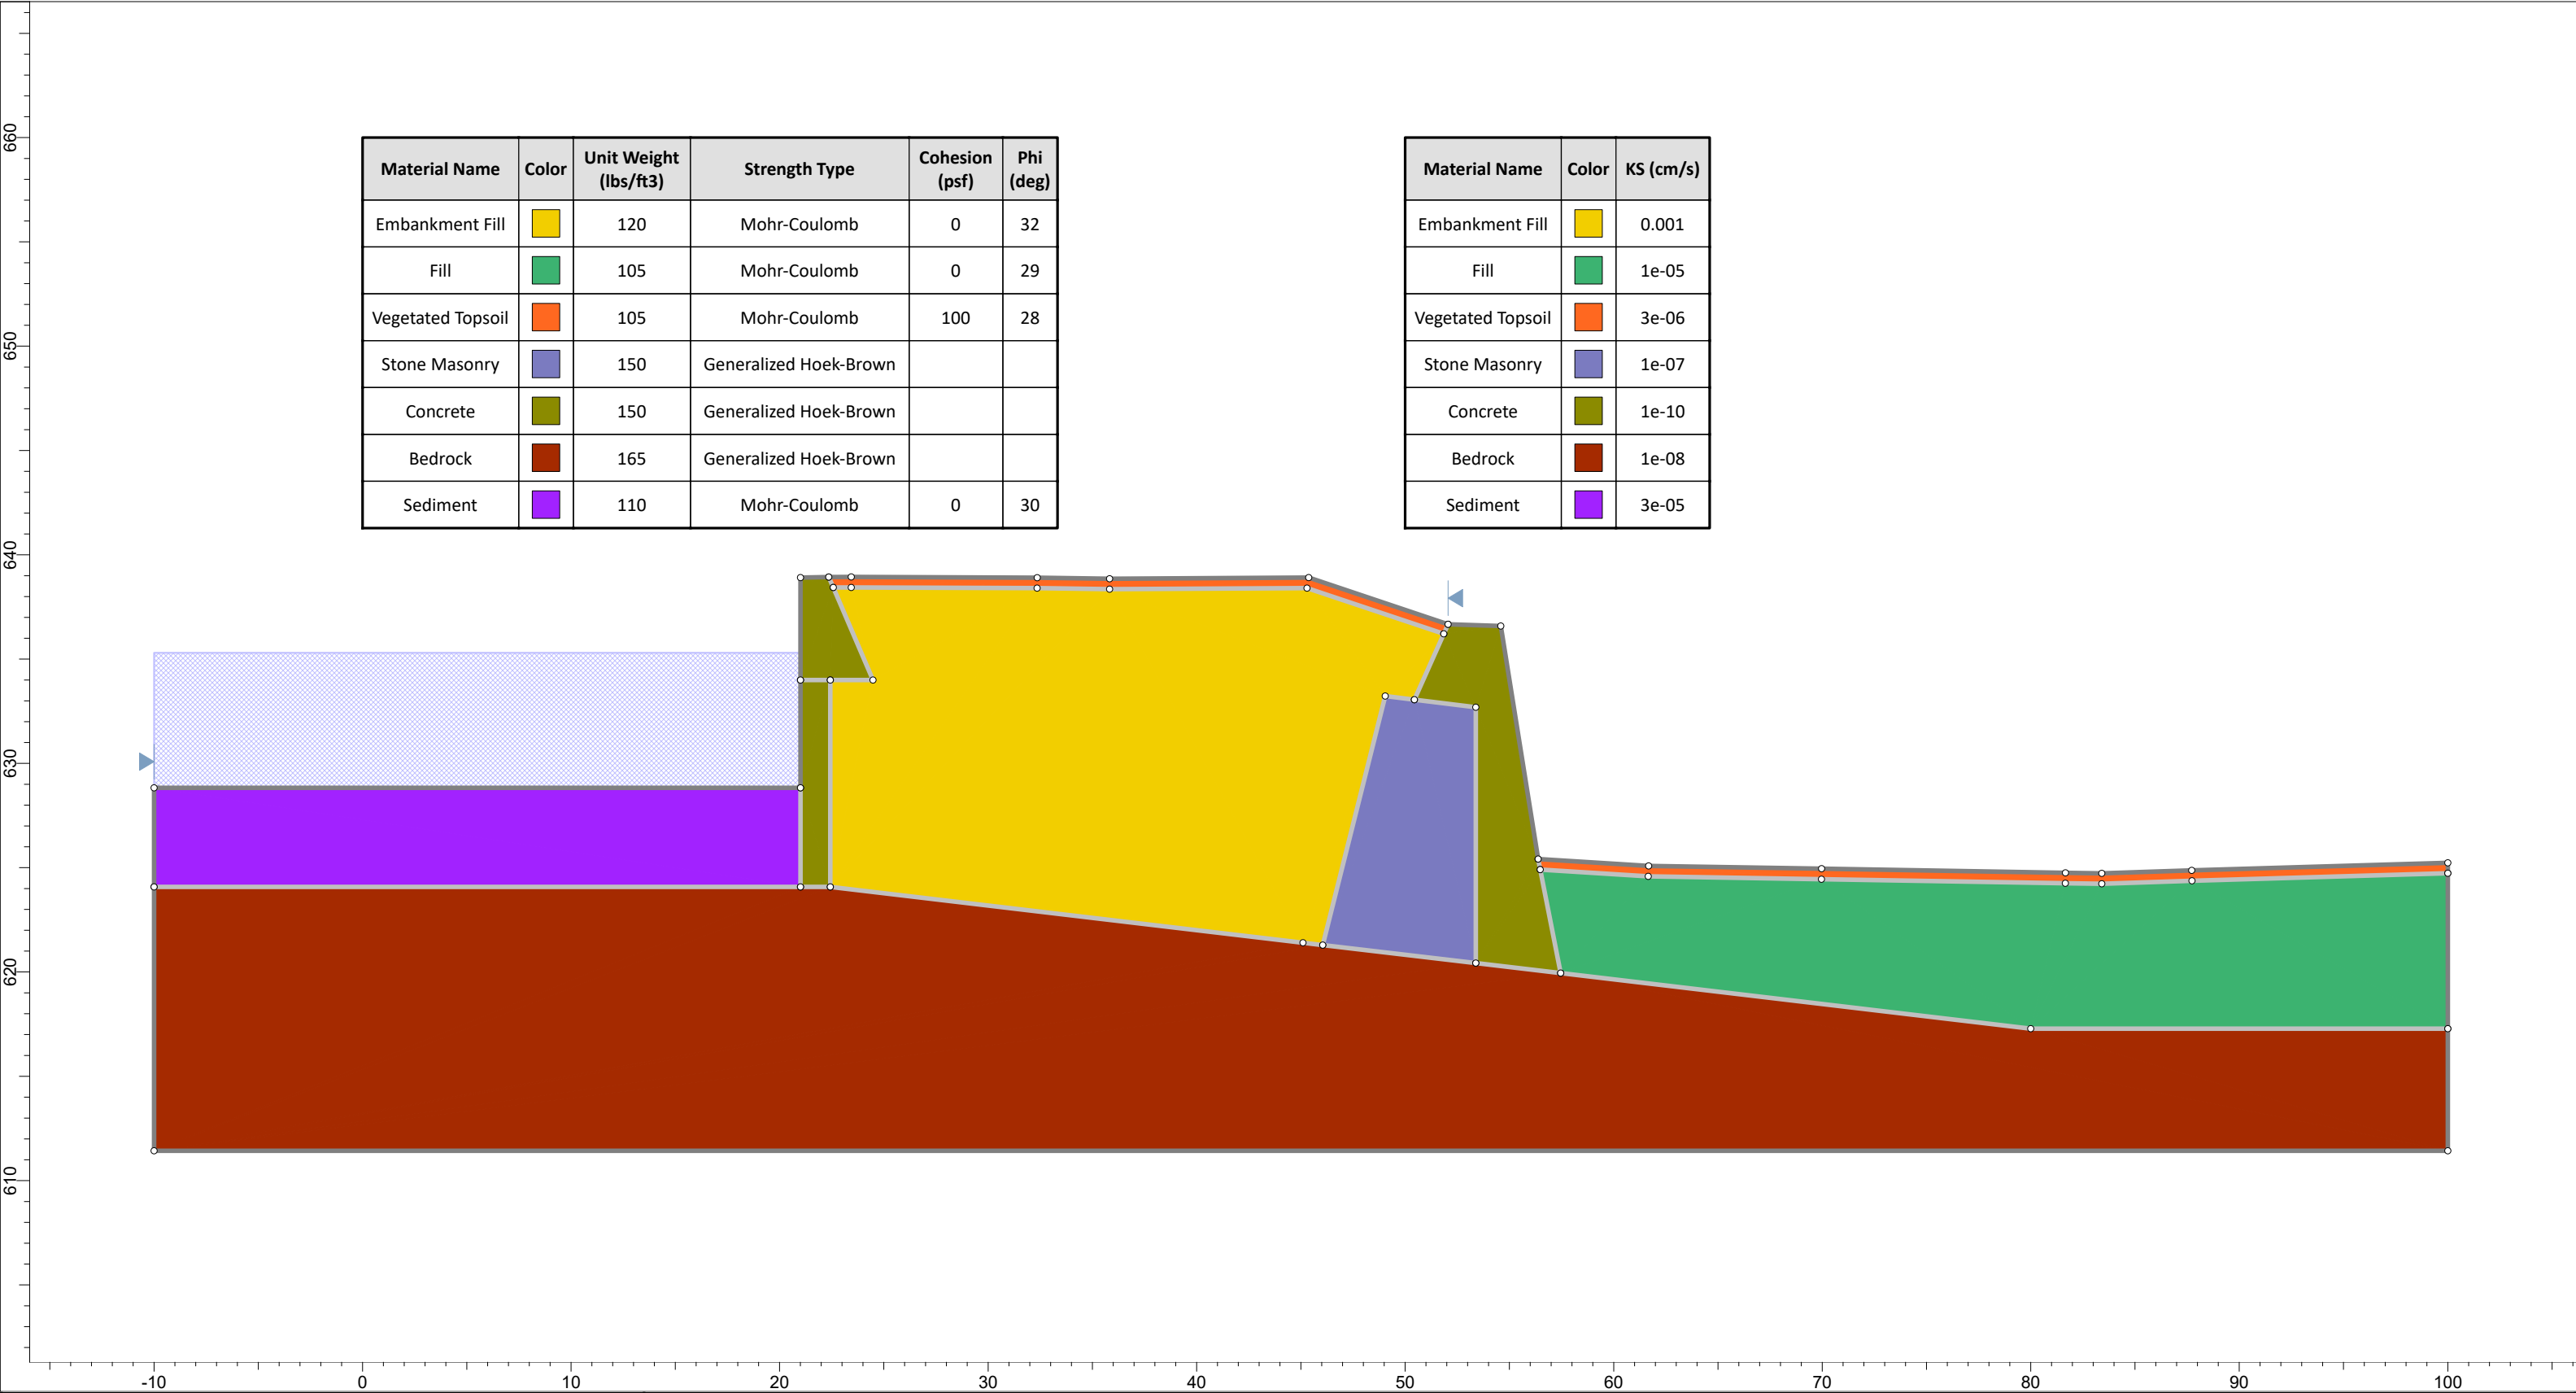
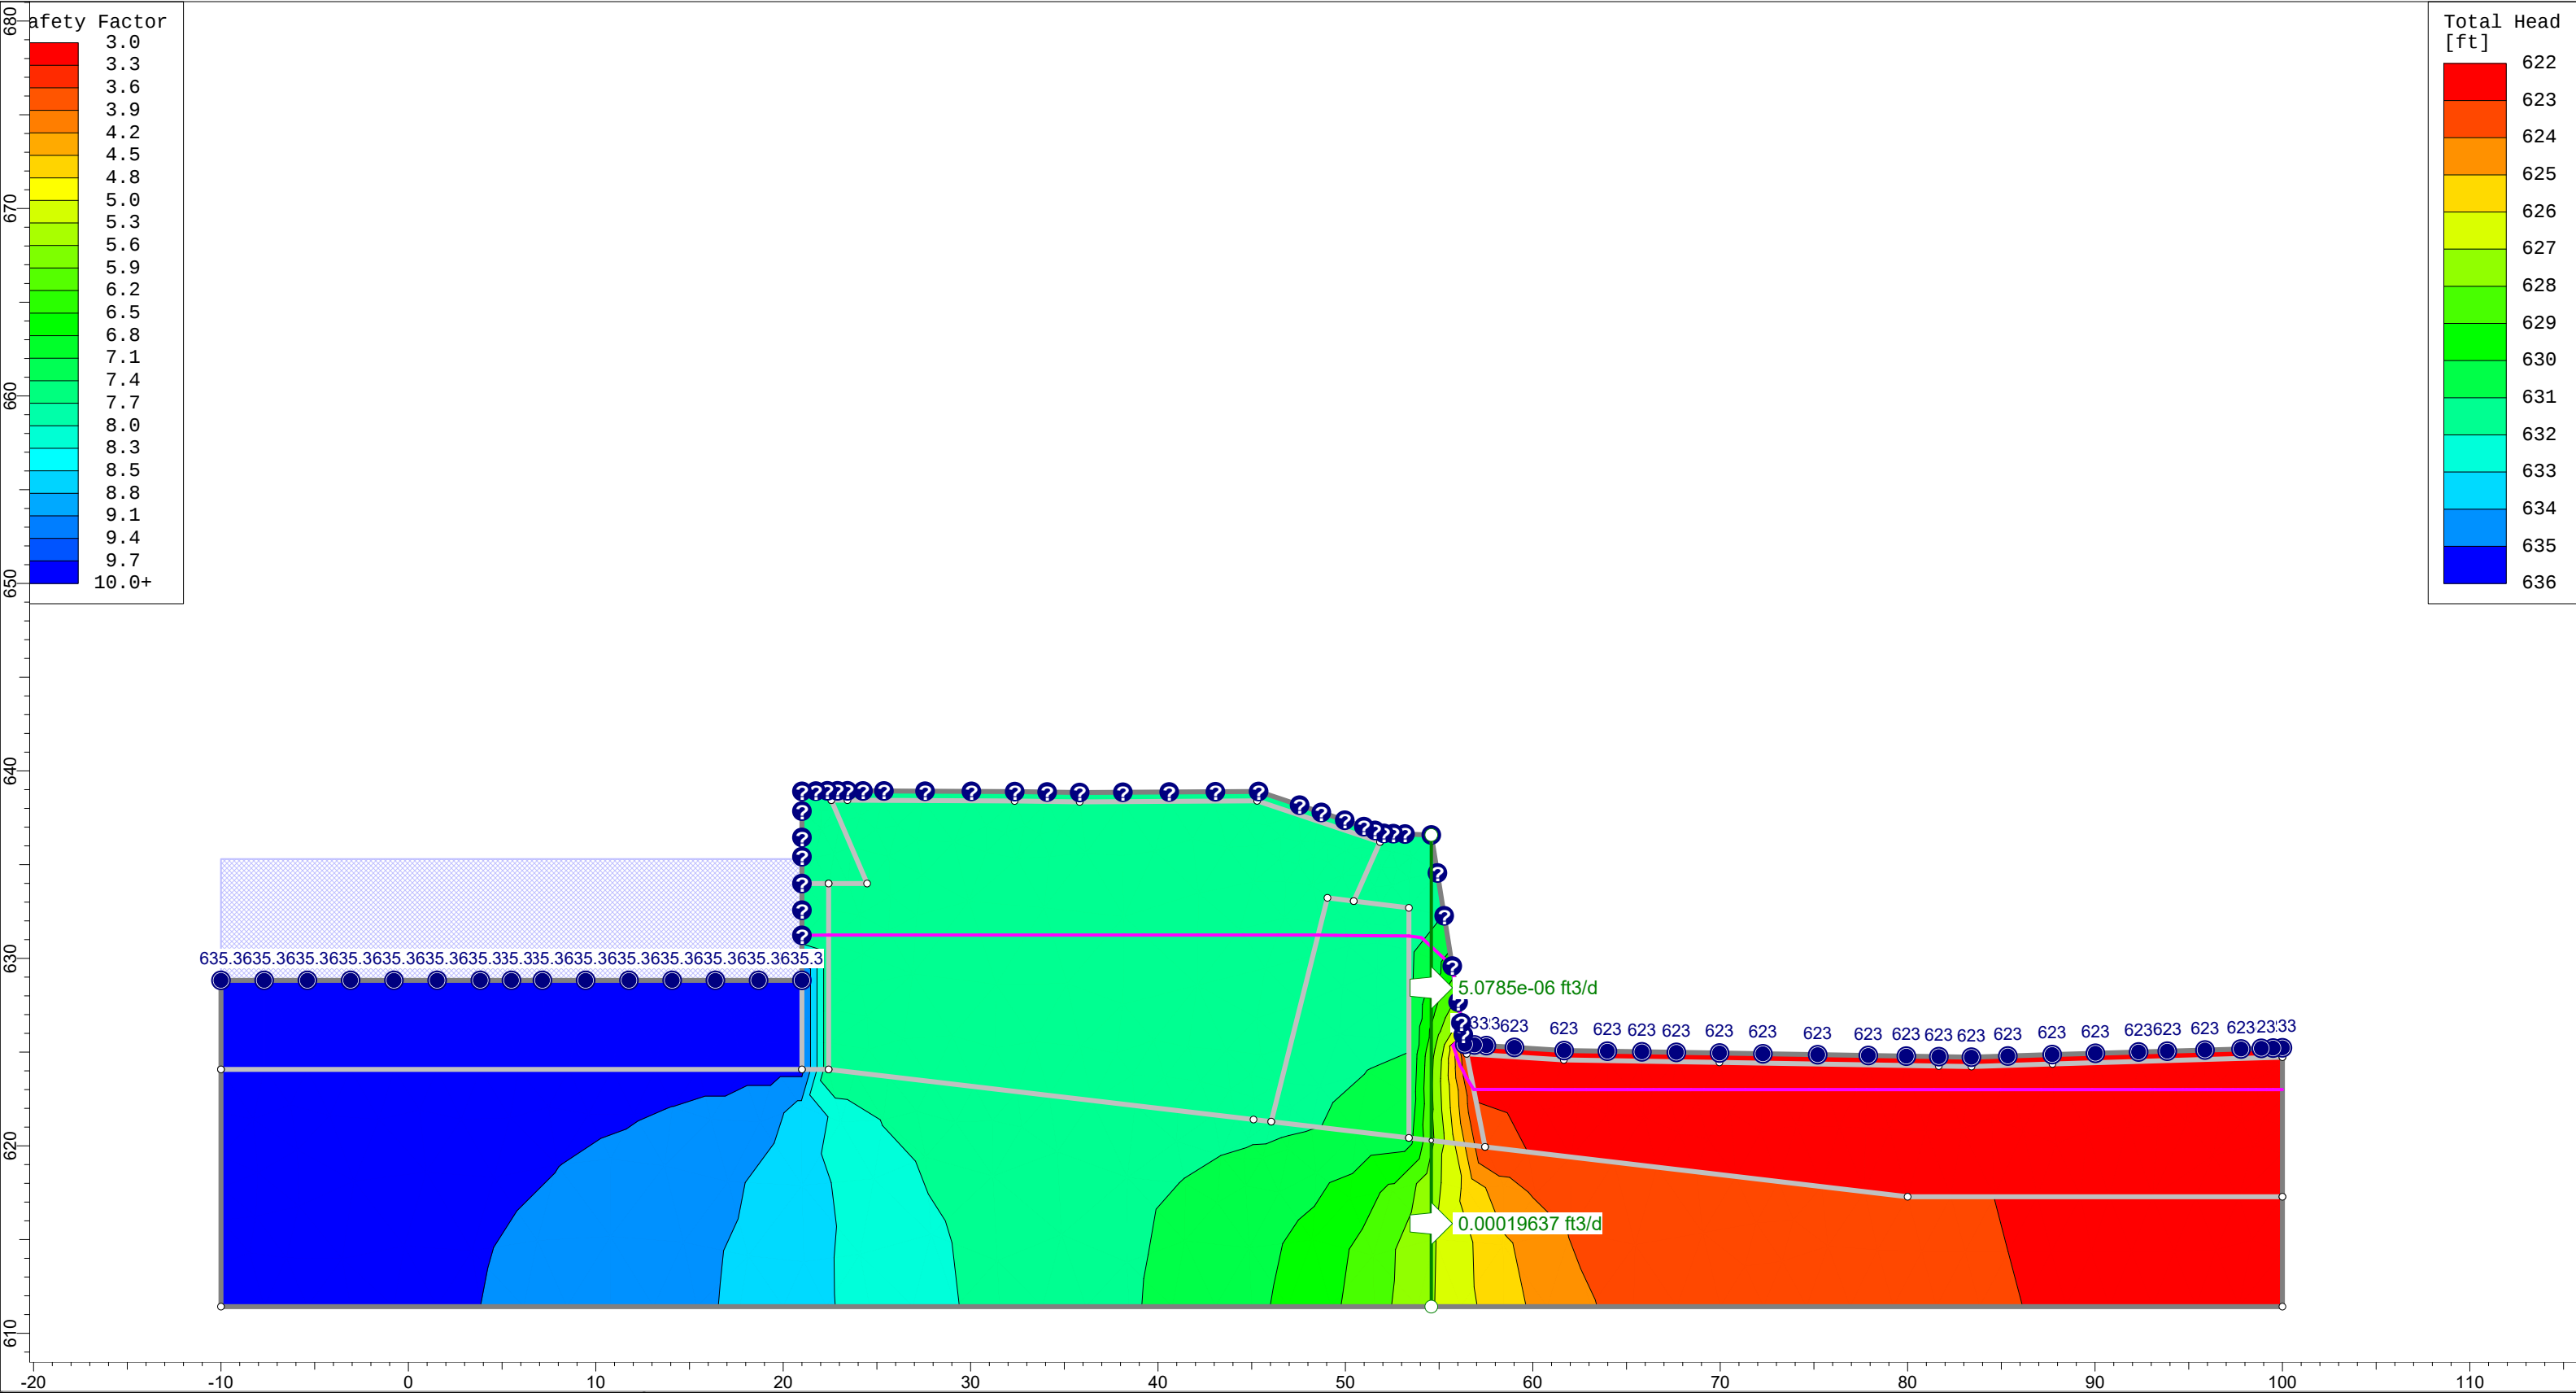
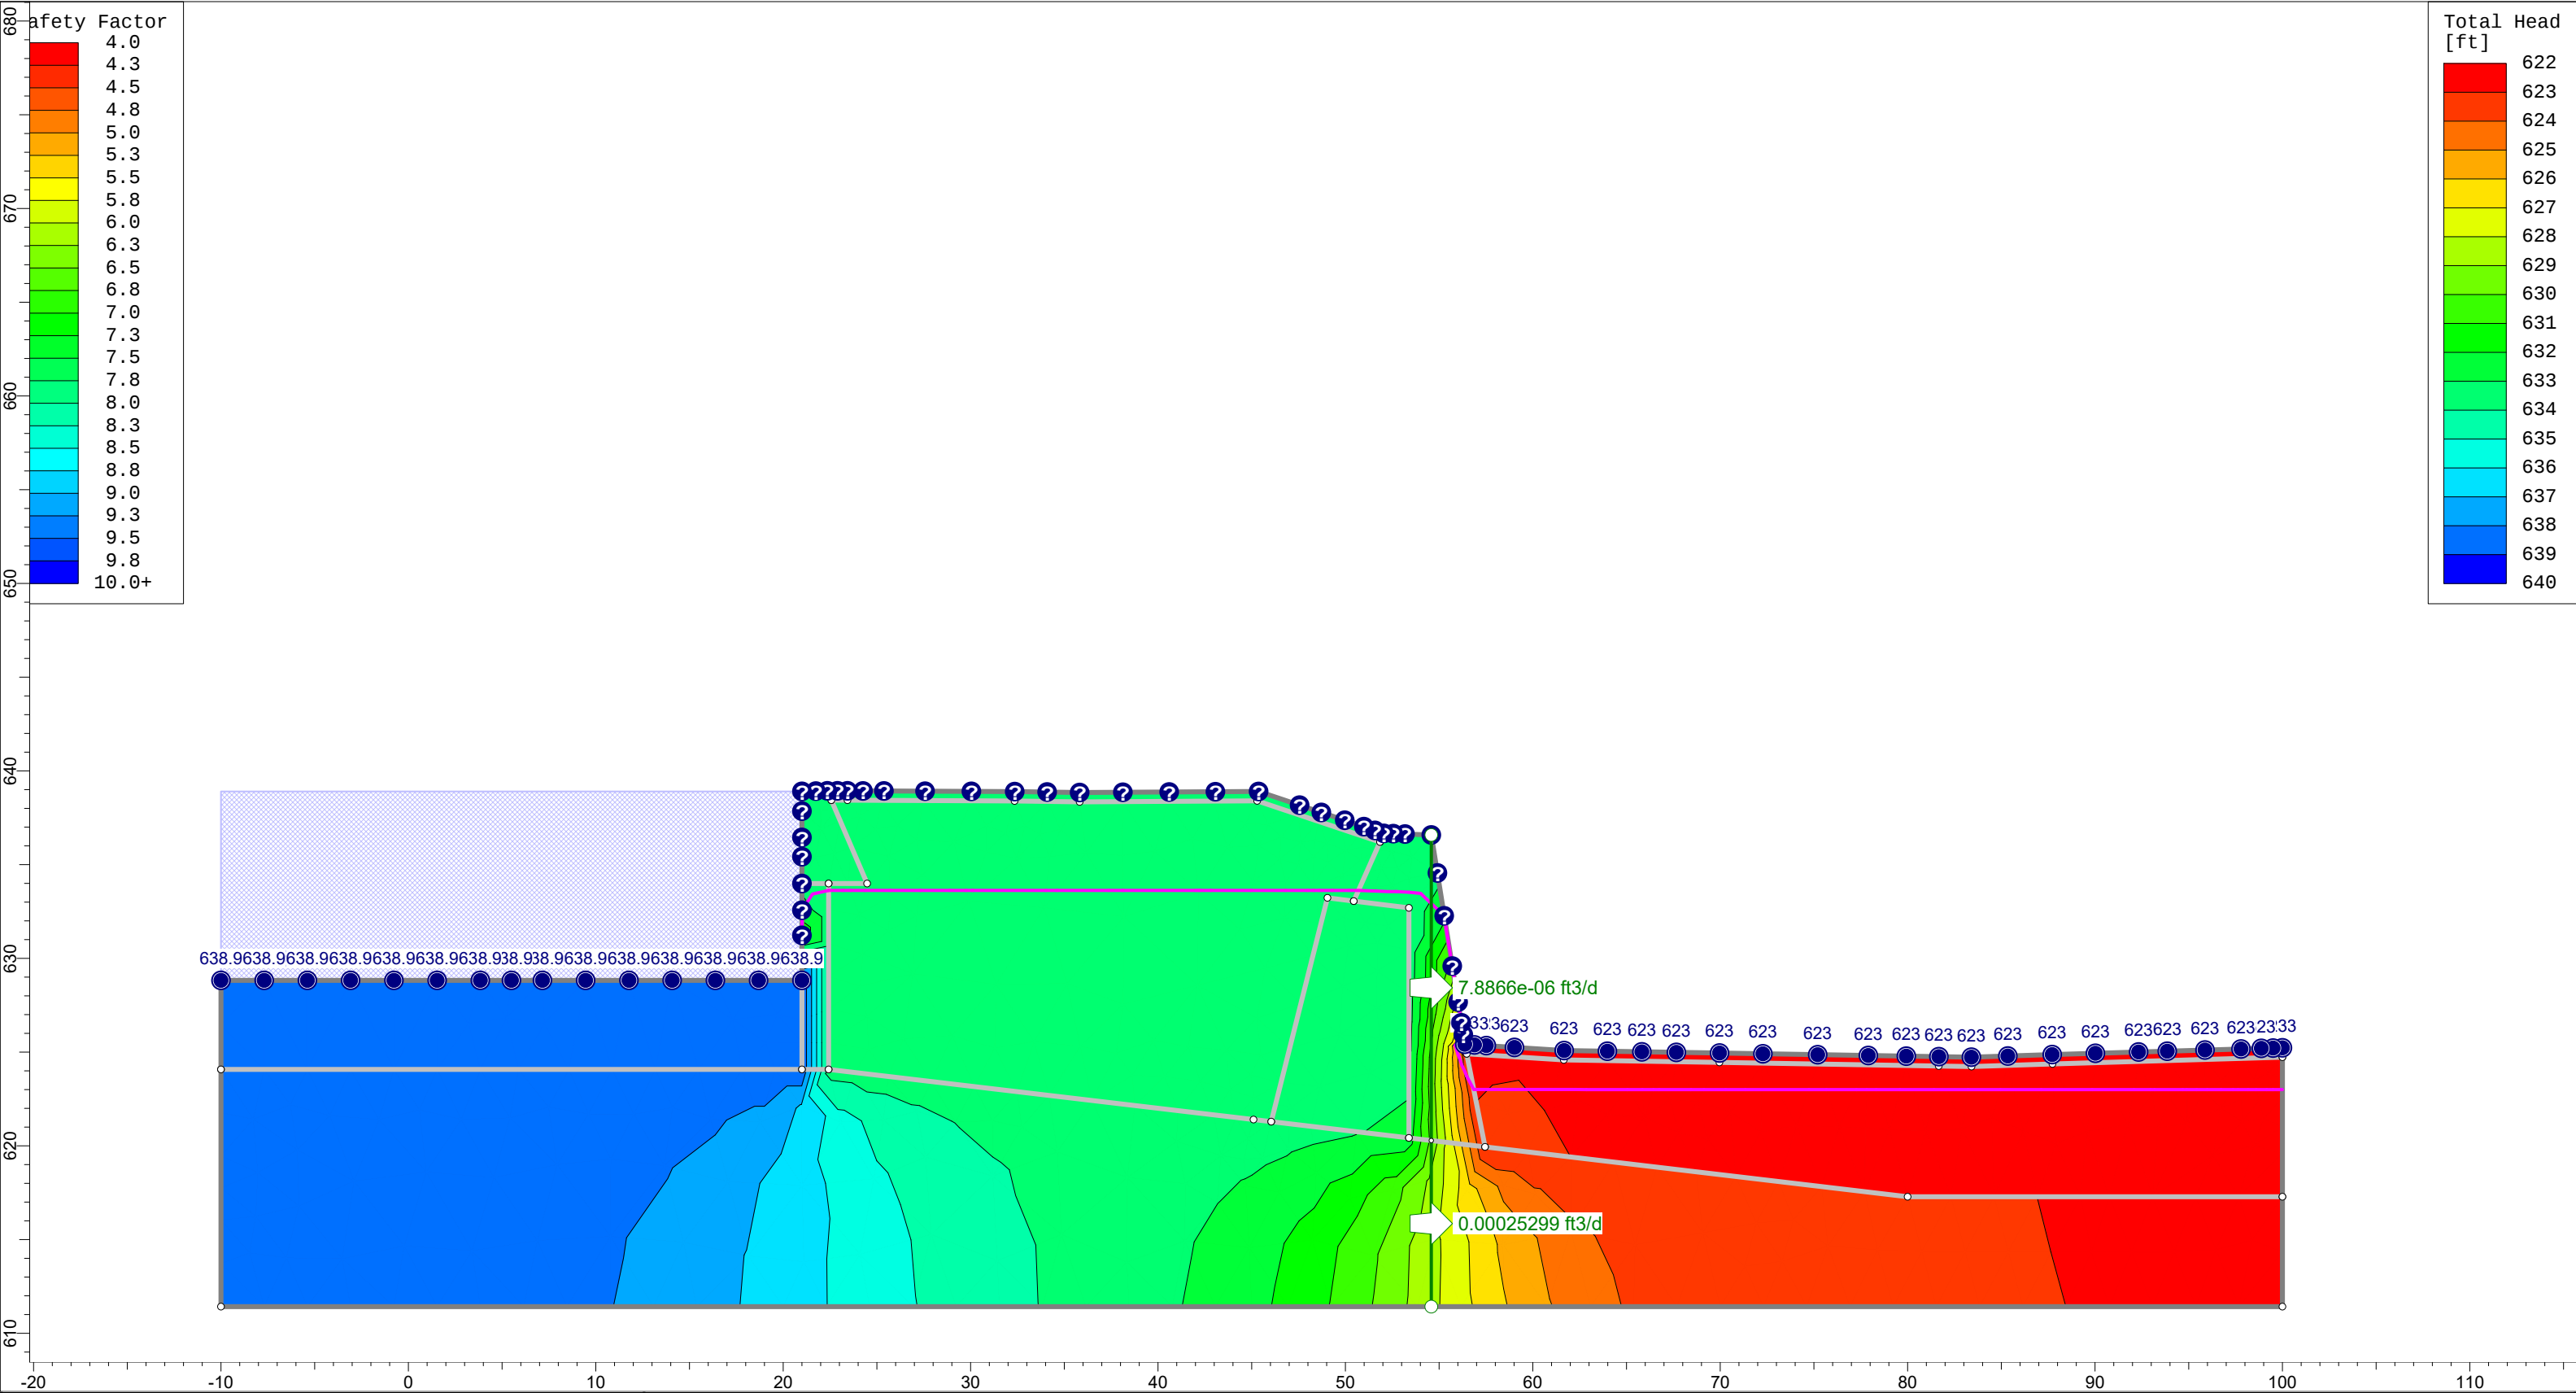
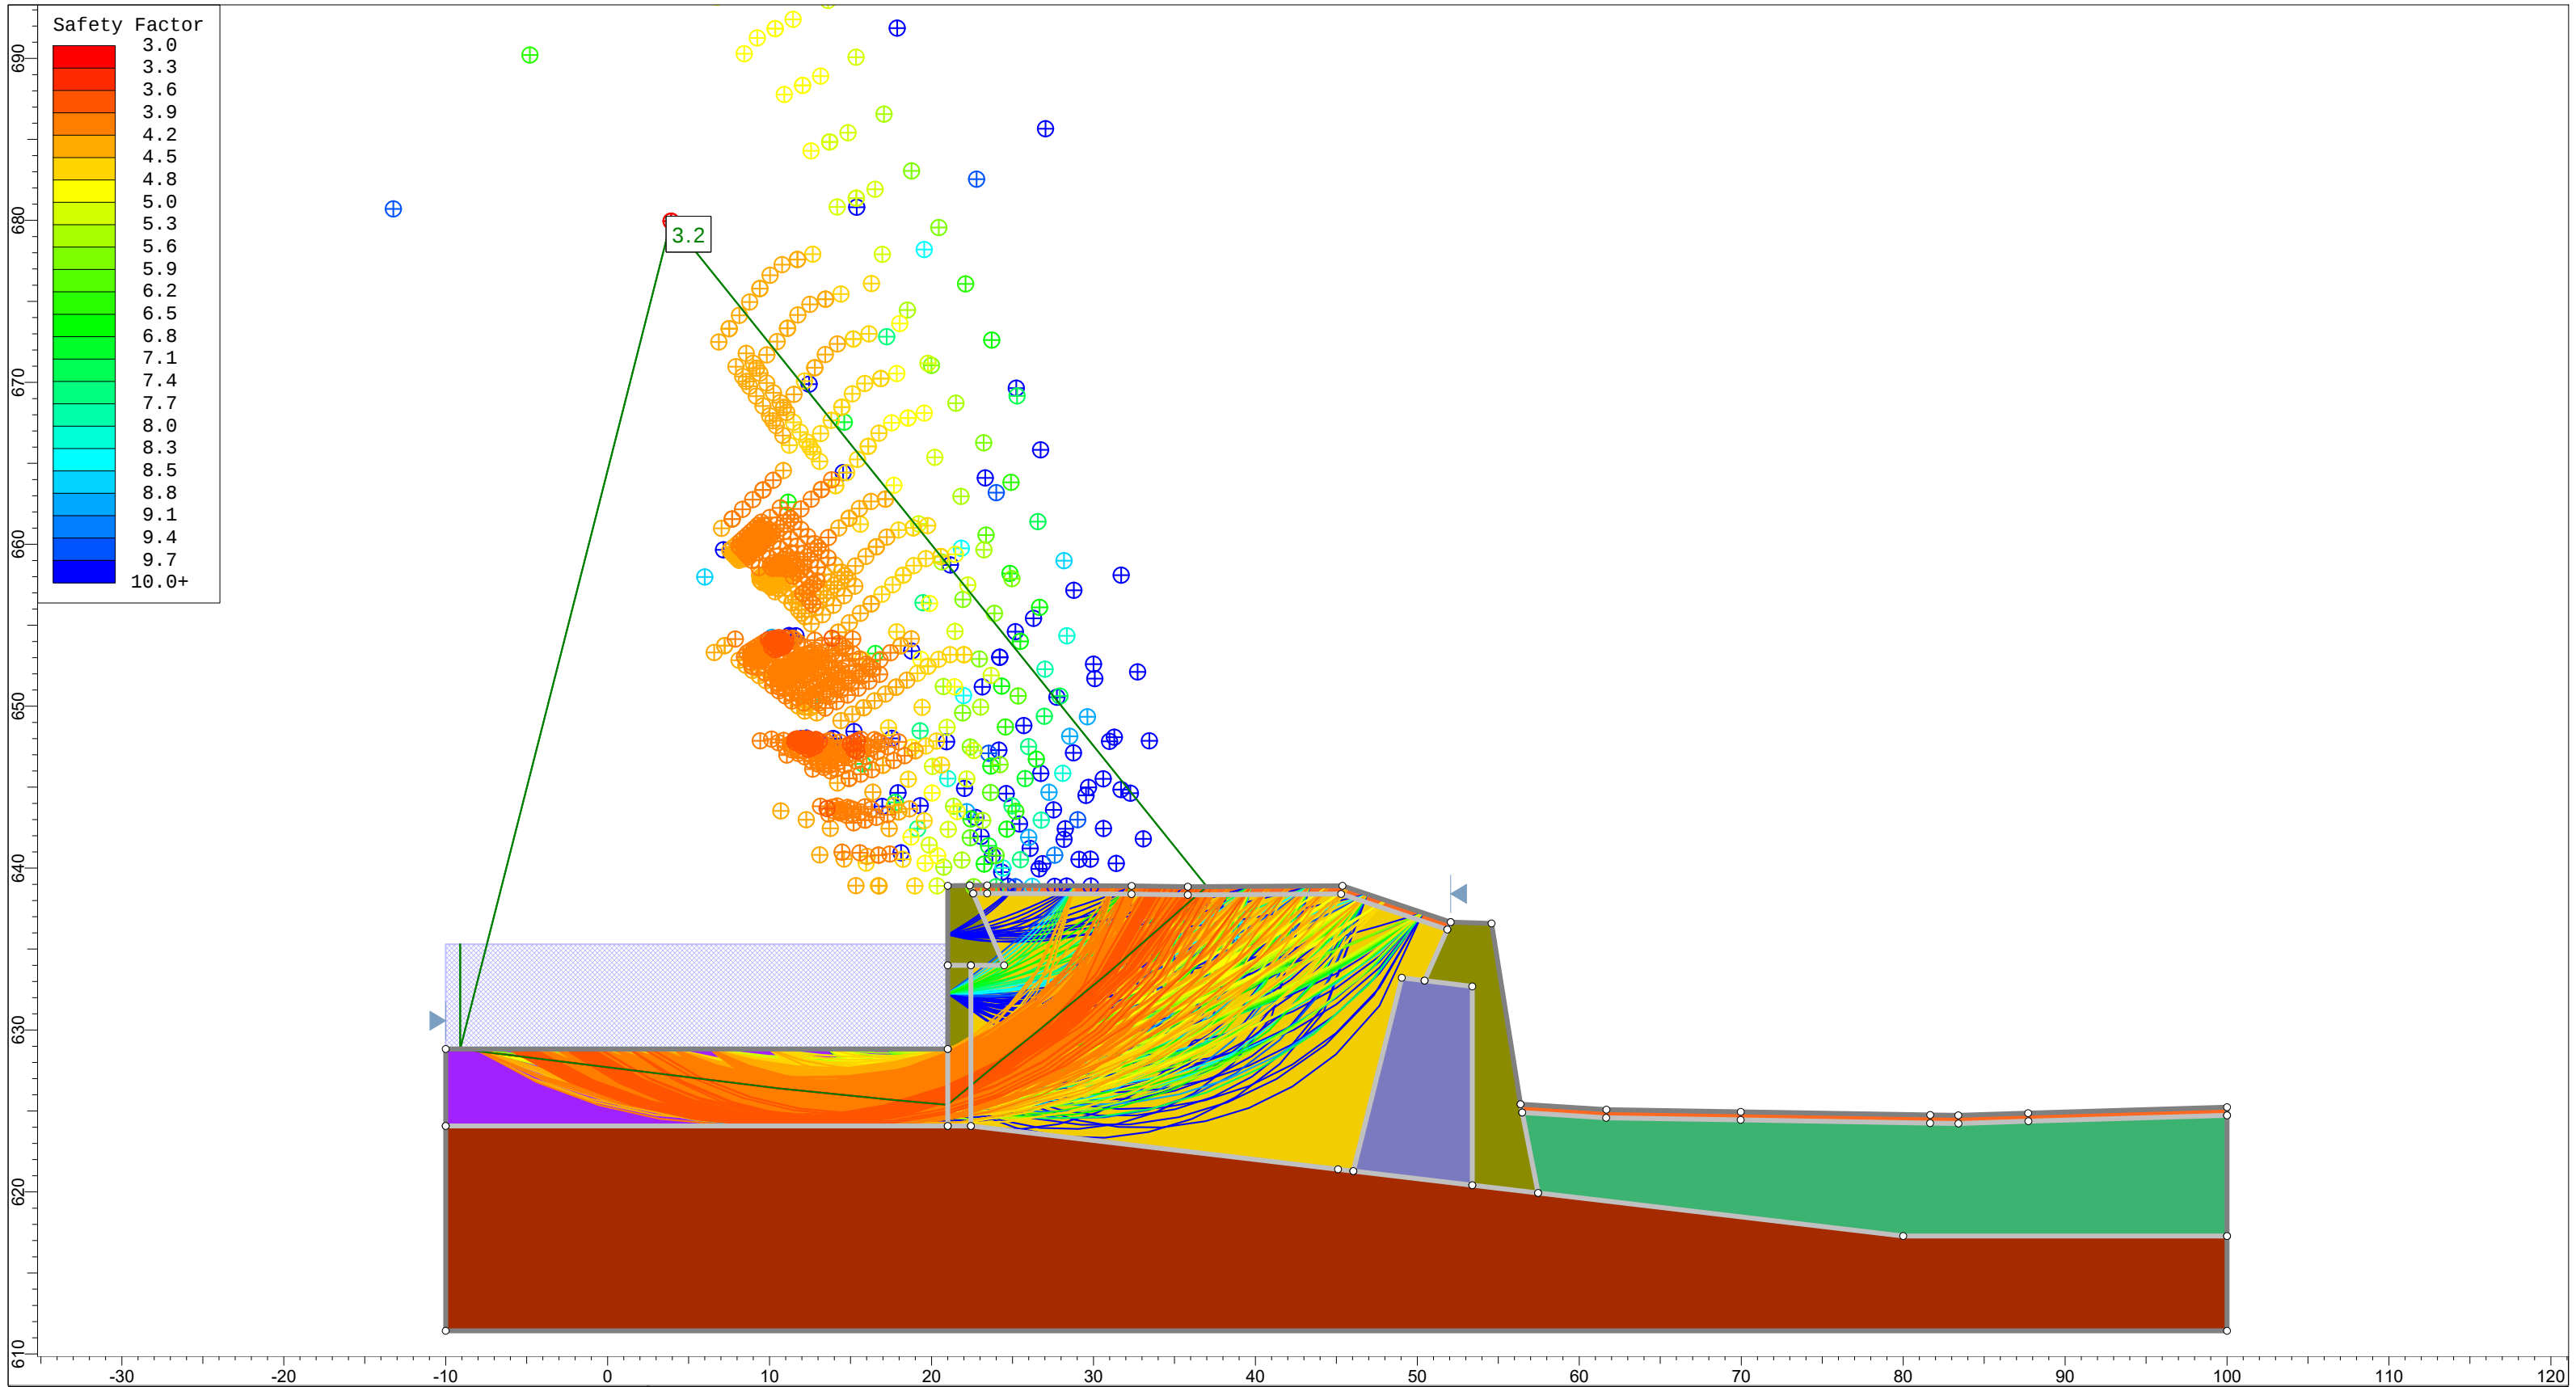
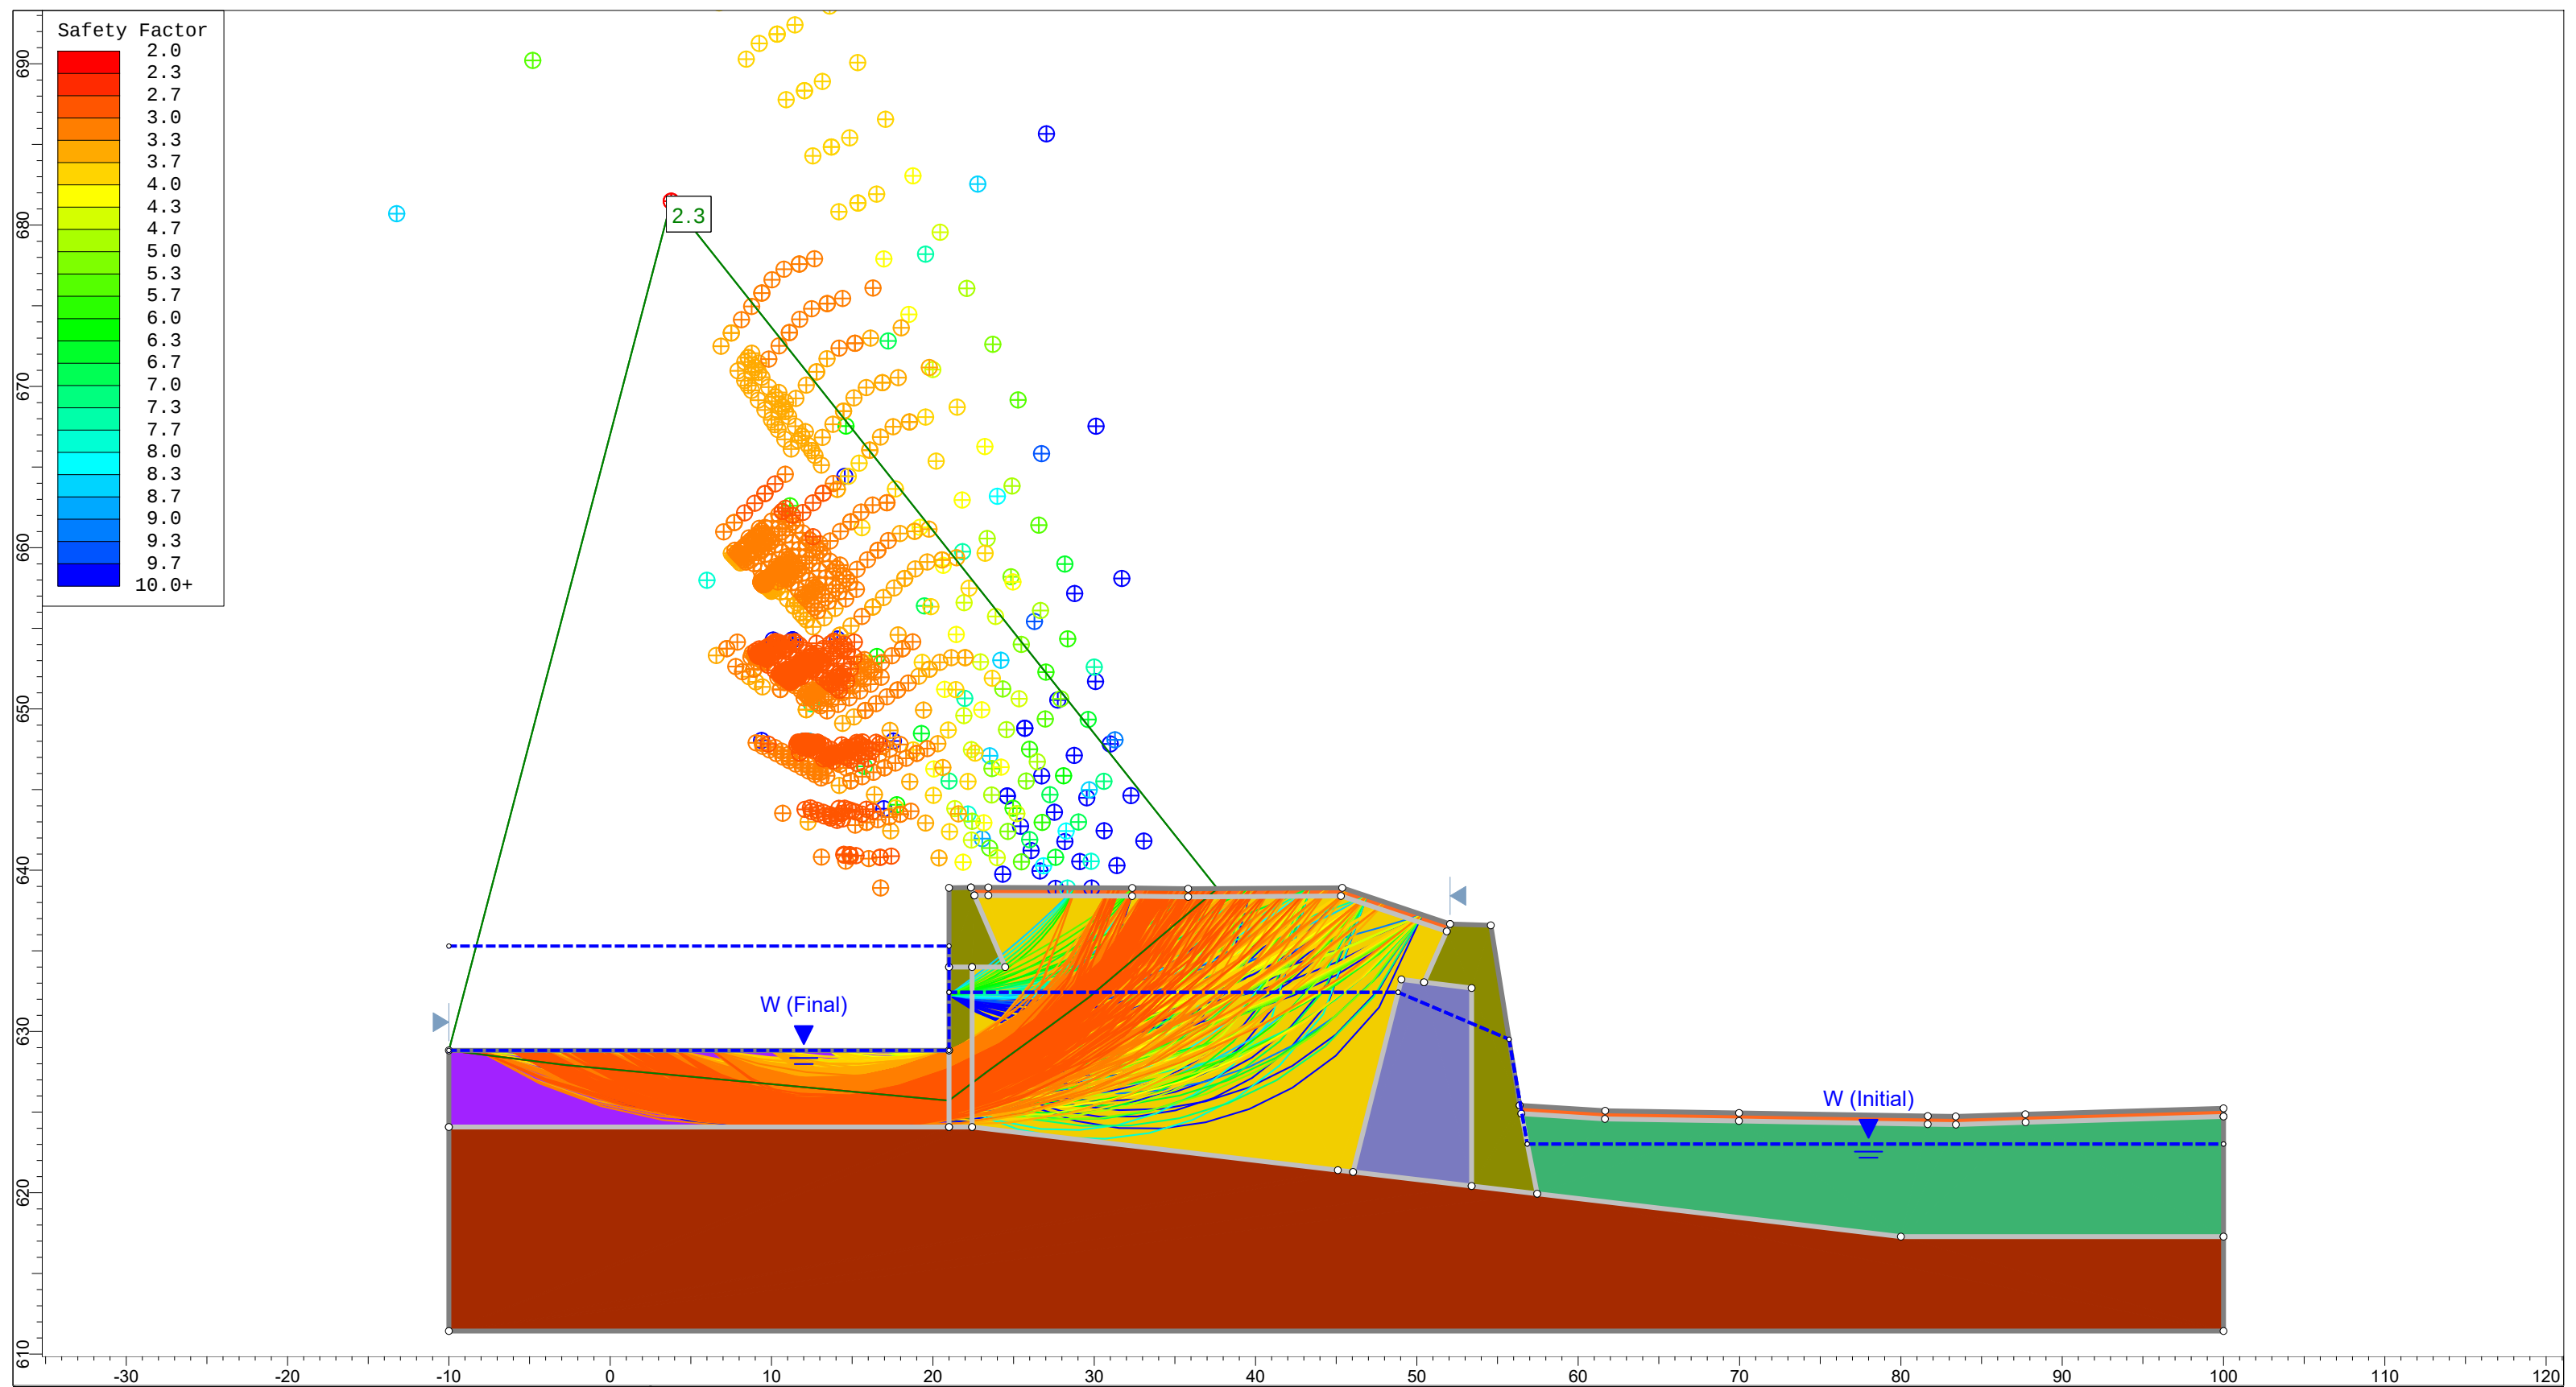
Table 3 presents the results of our stability analysis and compares them to the minimum factors of safety (FOS) recommended by the DCR guidelines. Graphical output, illustrating the predicted failure planes, is included in Appendix E.

The upstream and downstream slopes of the dam embankment are generally stable and meet the required factors of safety for the loading conditions required by 302 CMR 10.00 Dam Safety. The global minimum factors of safety for the downstream slope are along

shallow failure planes, and failure along these planes would likely result in minor sloughing. The deeper-seated failure circles have factors of safety of greater than 5.

It should be noted that the Slide software does not evaluate the structural stability of the retaining walls. If the upstream and/or downstream retaining walls are to be re-used or re-purposed as part of the dam rehabilitation, it is recommended that they be evaluated by a Structural Engineer for stability with respect to sliding and overturning.
