APPENDIX B  
**Photos**

## **Sediment Management Plan McTaggart's Pond Dam Fitchburg, MA**

**To:** Mr. Lenny Laakso, P.E. – Commissioner of Public Works, Fitchburg, MA  
**FROM:** Jason M. Perry, Sr. Env. Scientist; Daniel R. Buttrick, P.E., Sr. Engineer  
**DATE:** October 8, 2019

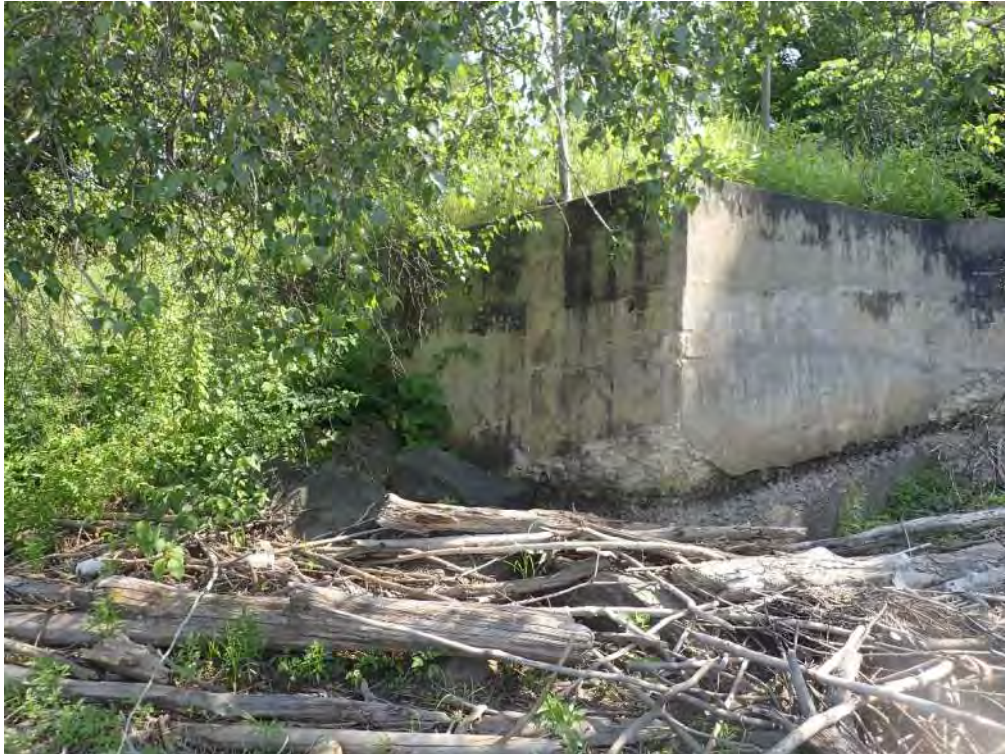
**Photo 11 – Overview of left upstream concrete wall (7/10/2019); note deterioration along waterline**

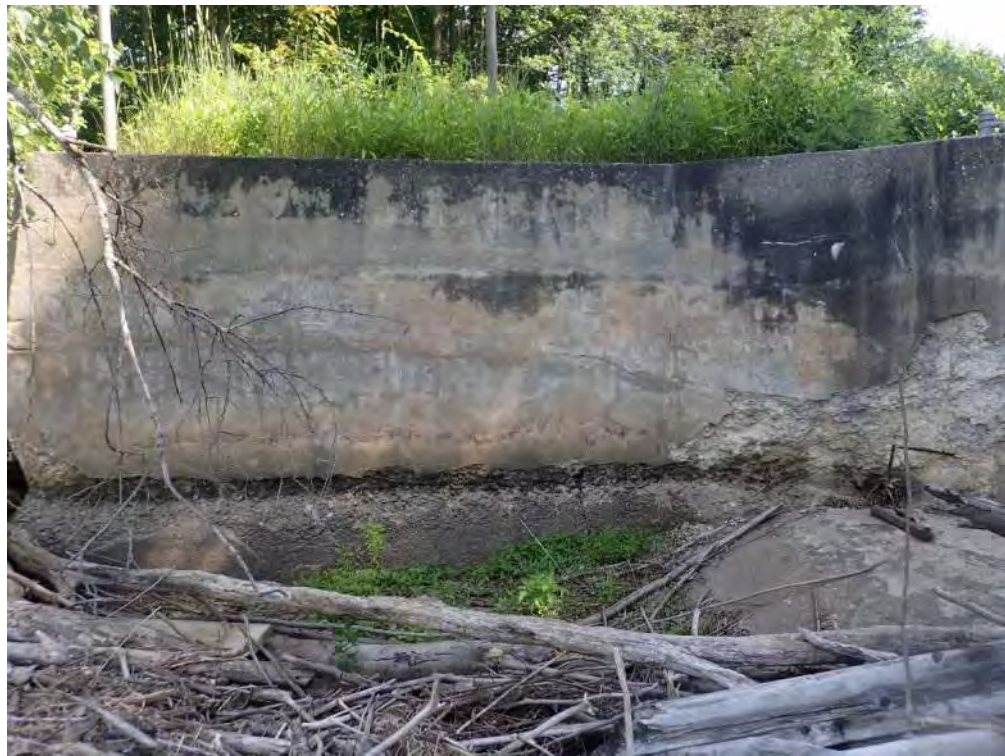
**Photo 12 – Overview of left spillway training wall (7/10/2019); note deterioration along waterline**

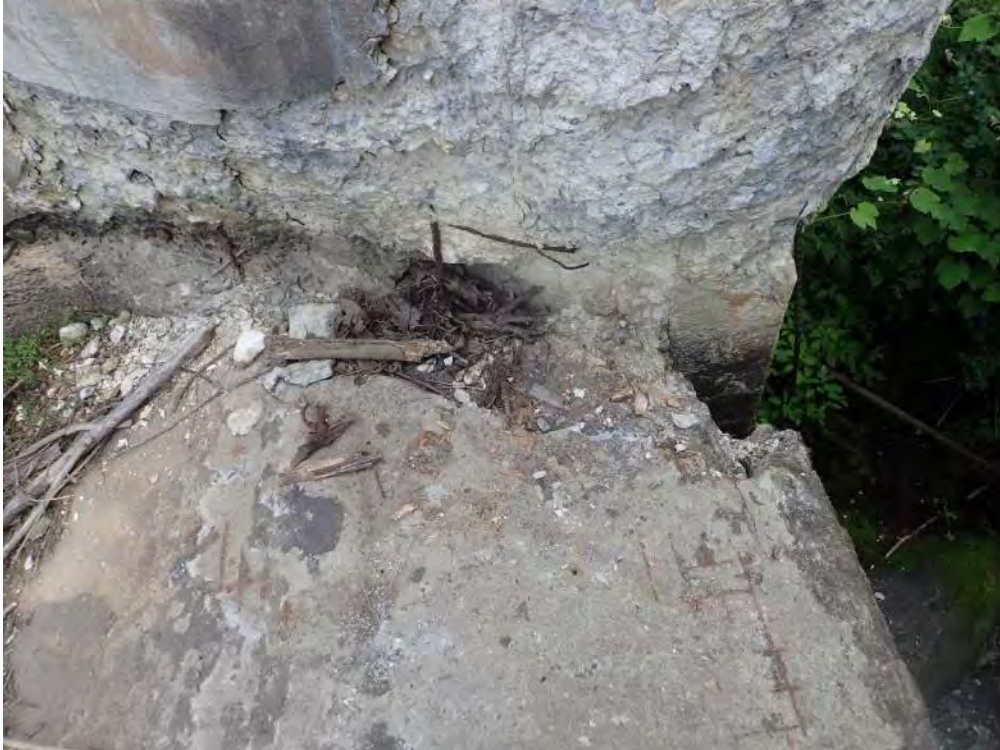
**Photo 13 – Deteriorated area at left training wall – spillway interface (7/10/2018)**

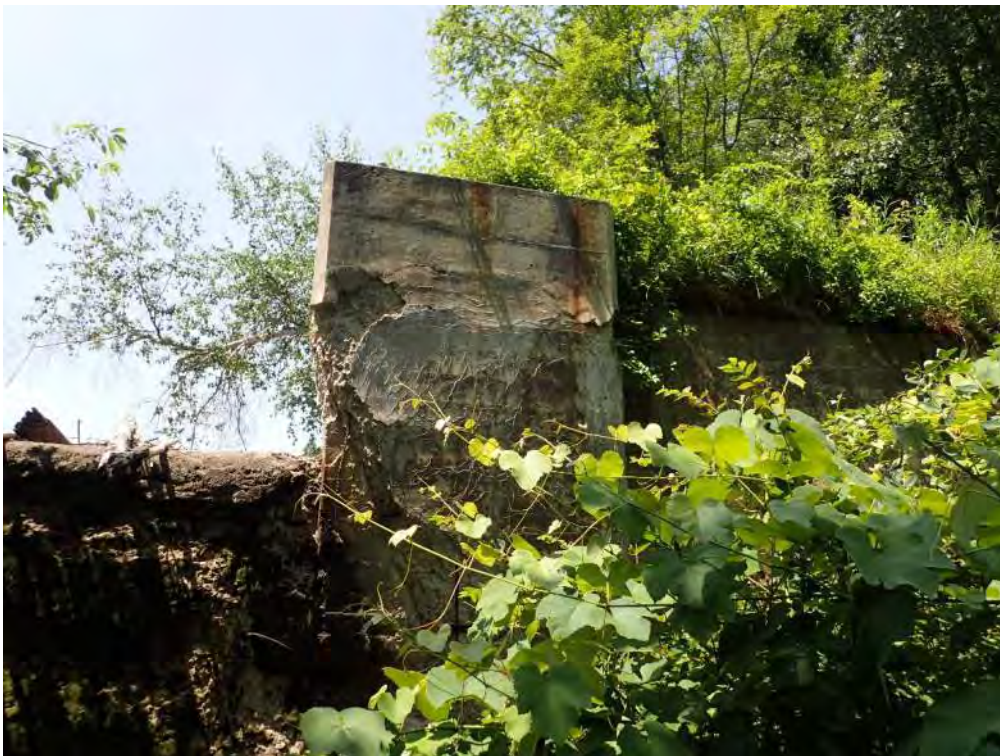
**Photo 14 – Overview of downstream left wall (7/10/2019); note spalls and loose concrete materials**

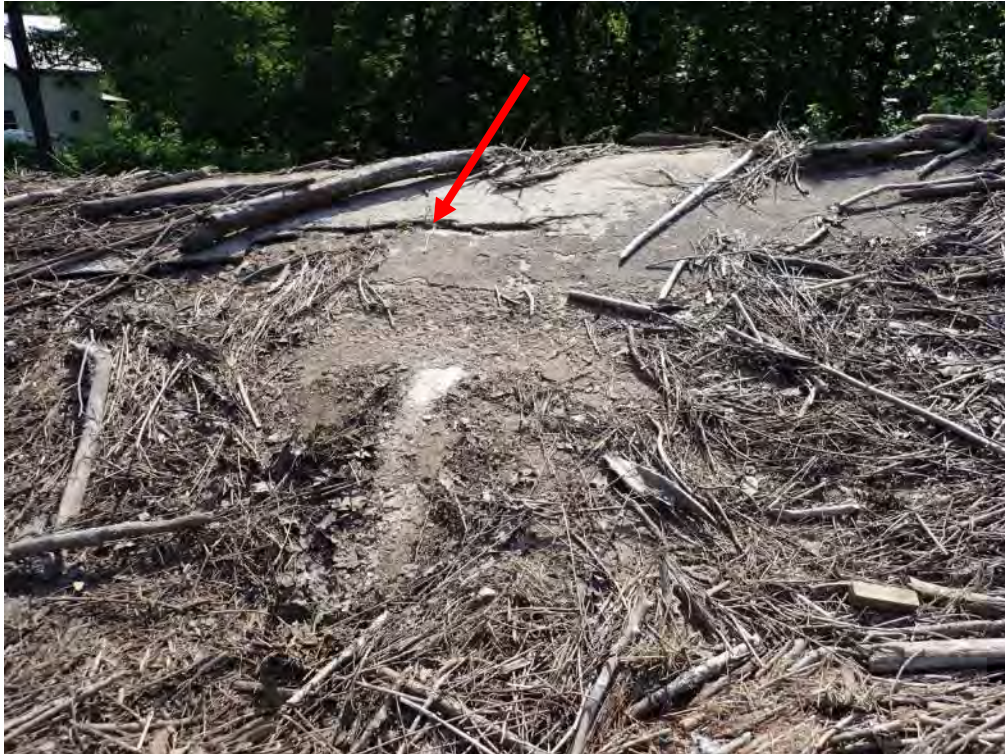
**Photo 17 – View of spillway crest (7/10/2019); note separation of cap from adjacent concrete**

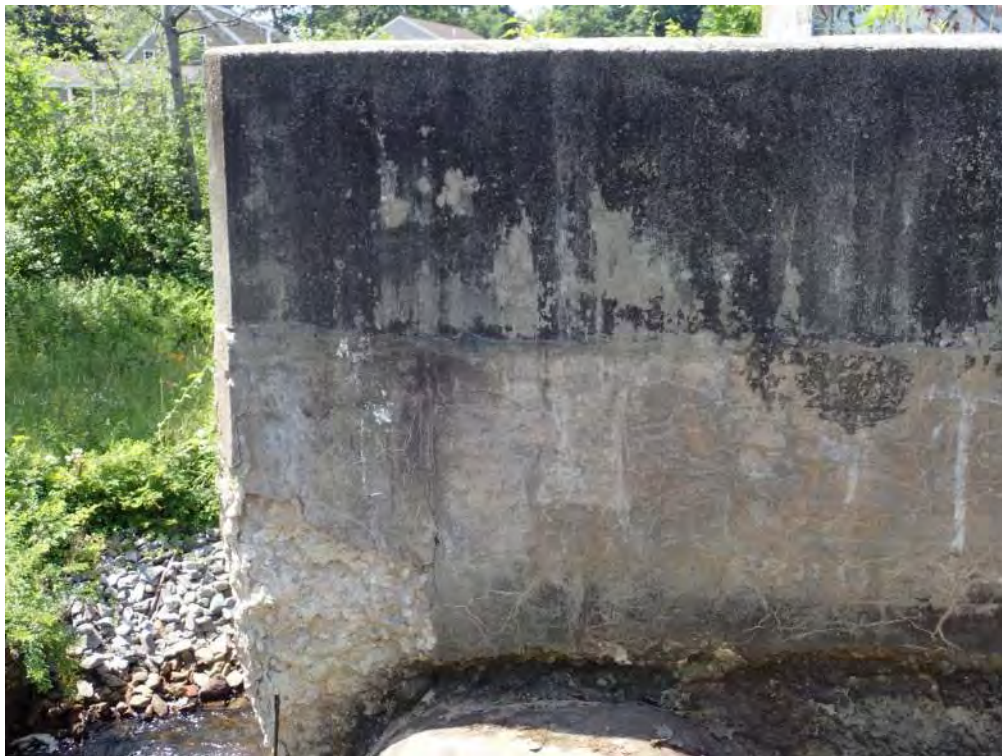
**Photo 20 – Downstream side of right training wall (7/10/2019); note deterioration at waterline and large spall at downstream end**

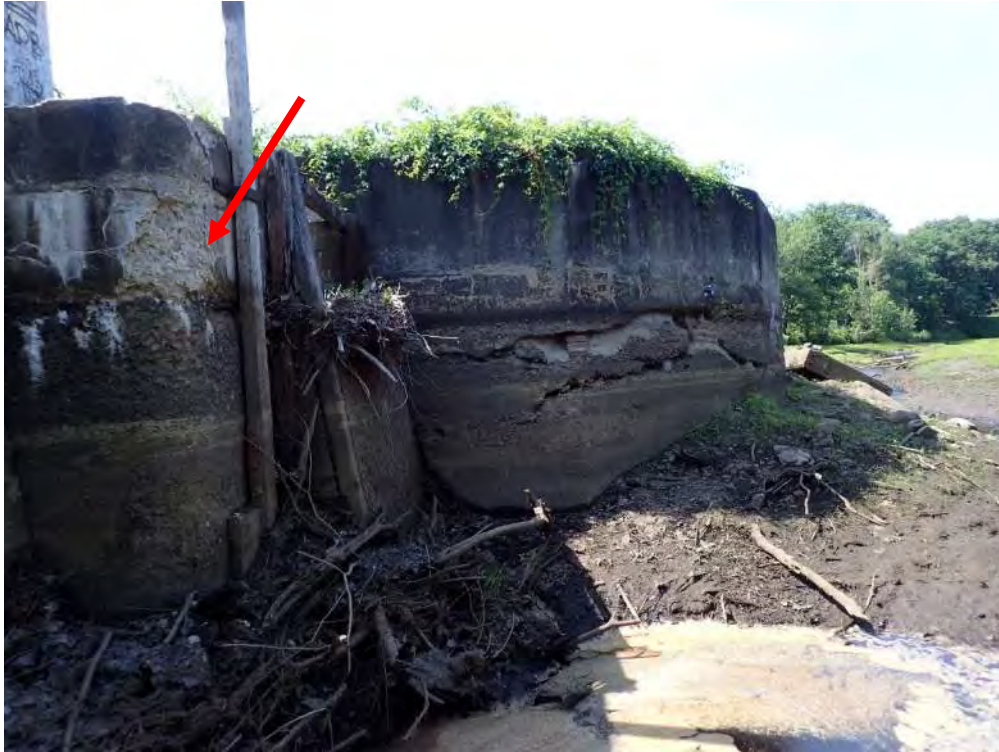
**Photo 21 – Overview of outlet structure and upstream wall (7/10/2019); note irregular spalls; area of concrete breakdown indicated with arrow**

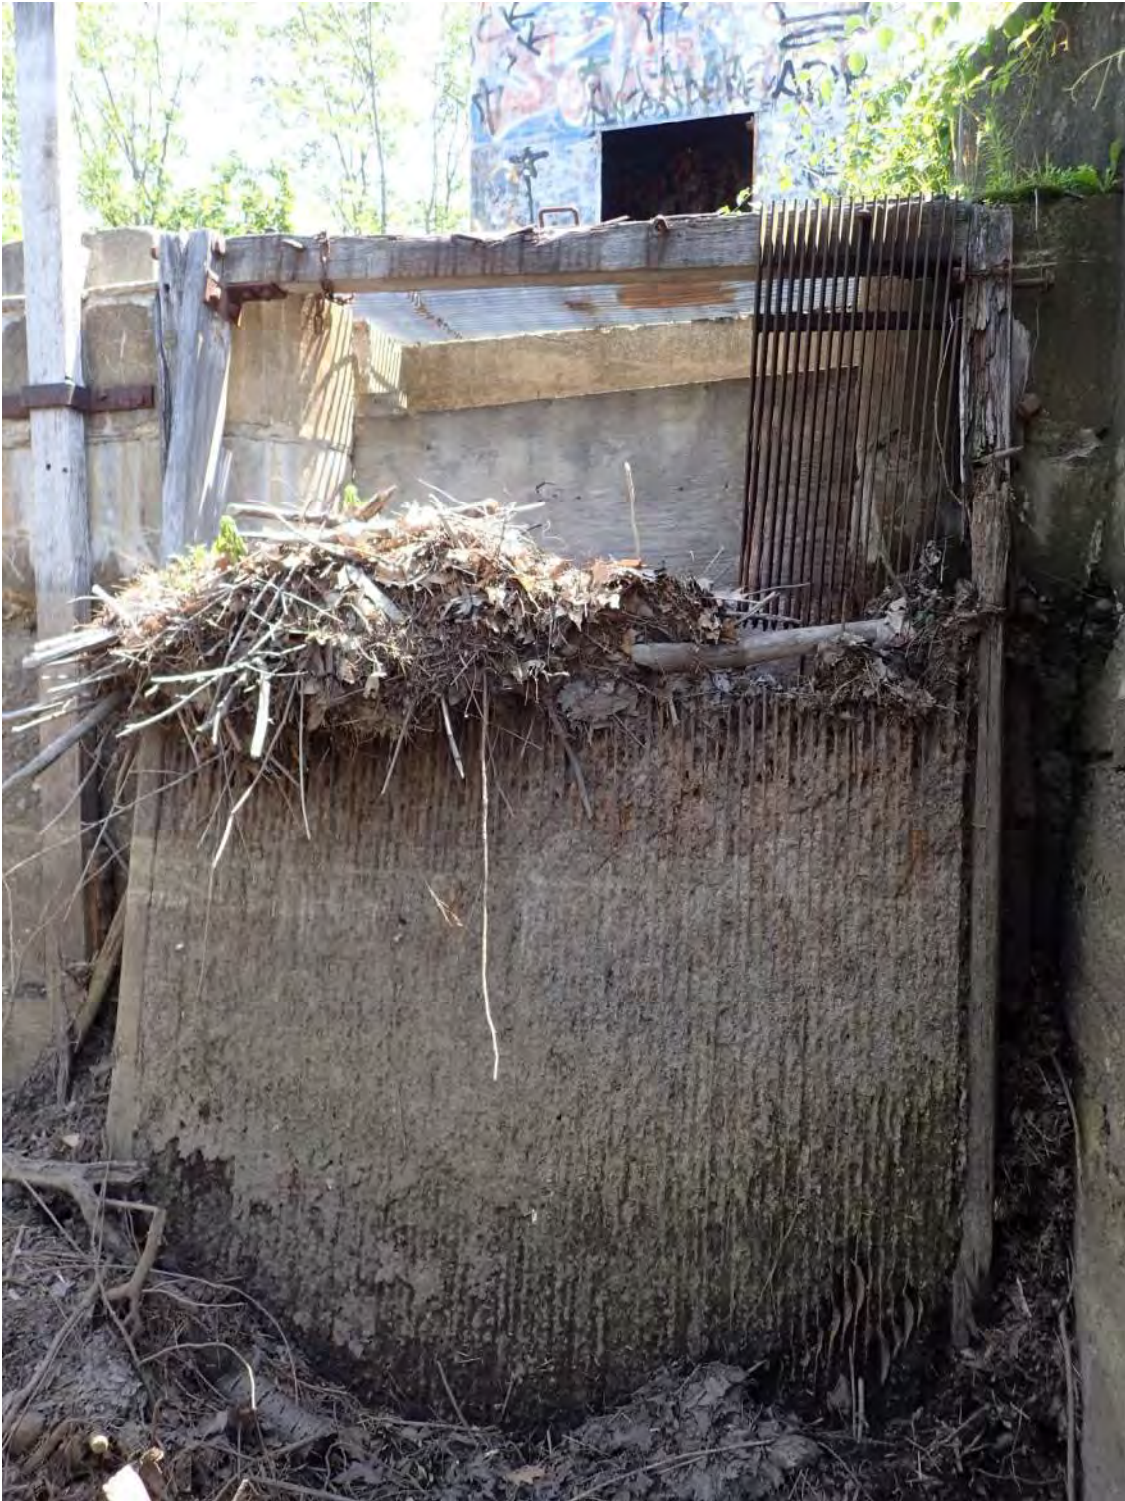
**Photo 23 – Deteriorated trash racks (7/10/2019)**

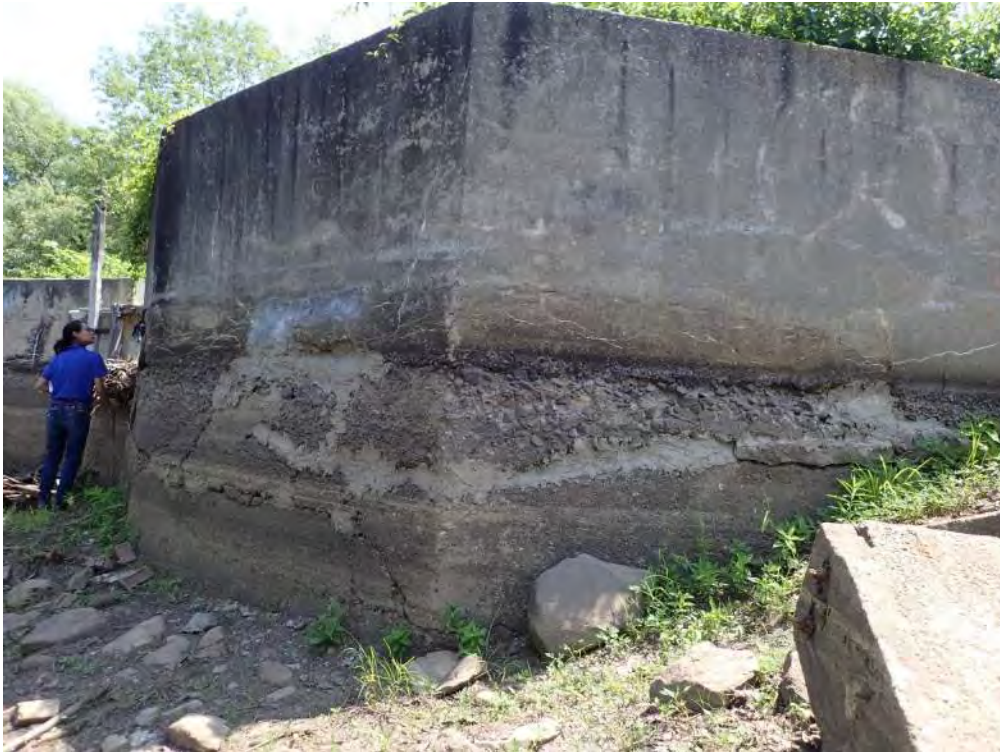
**Photo 24 – Deteriorated right upstream wall (7/10/2019)**

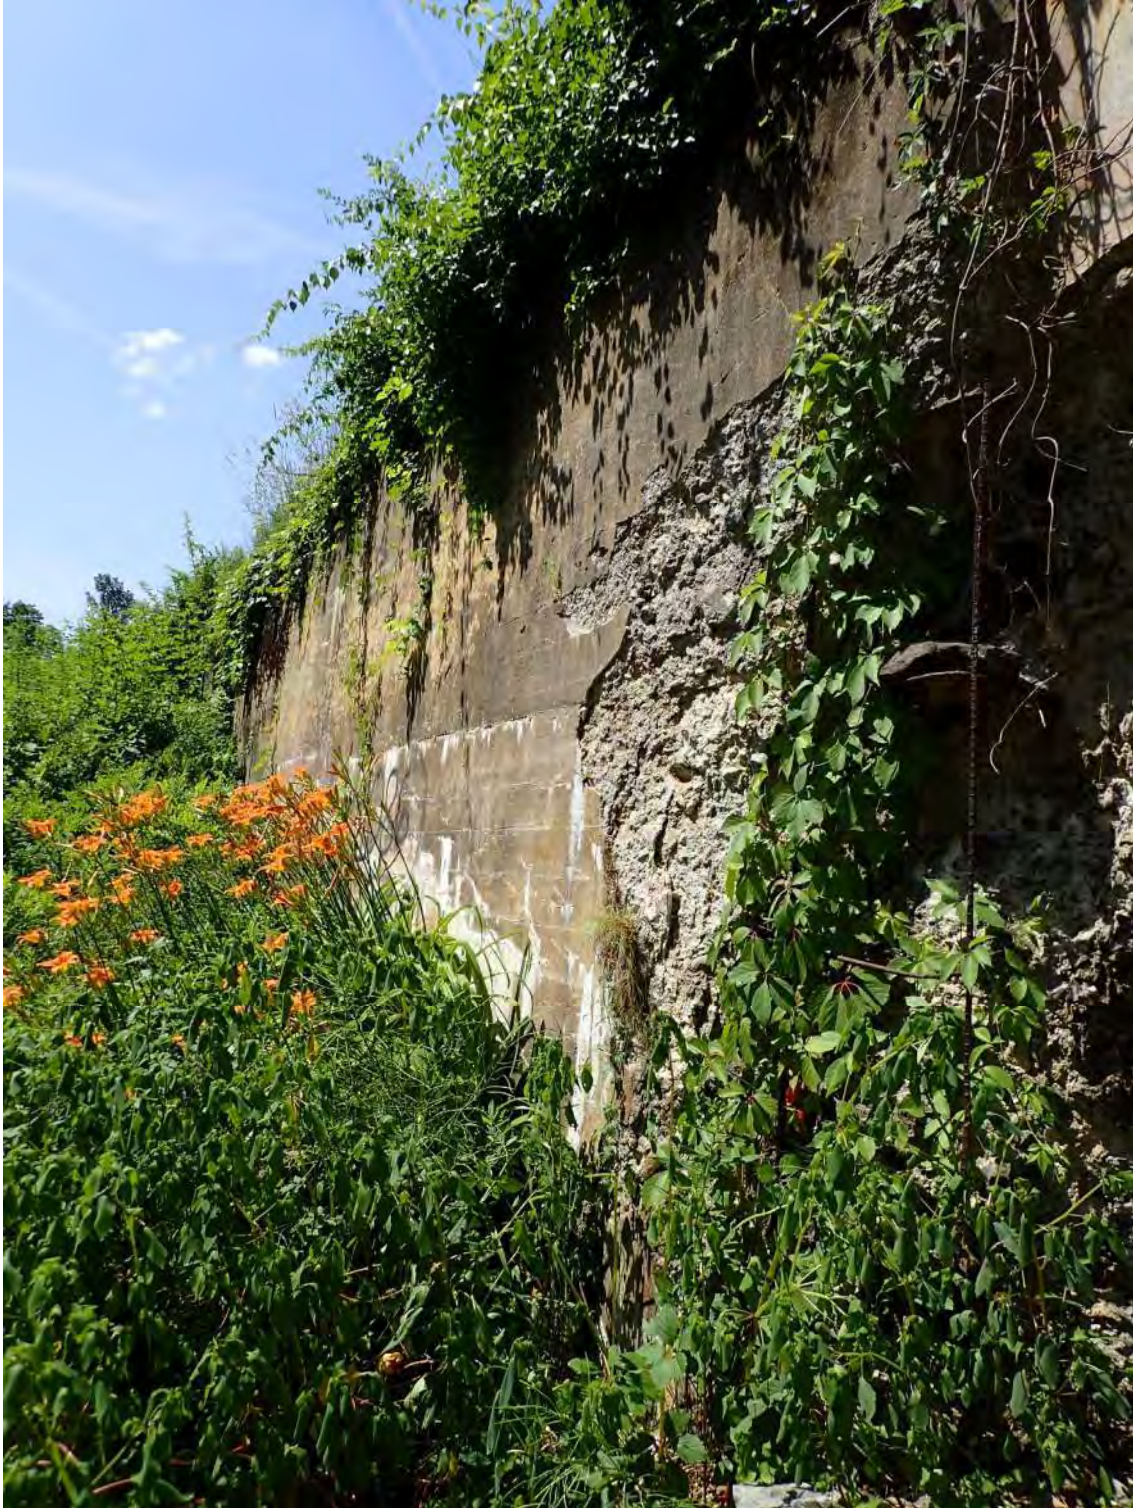
**Photo 26 – Right downstream wall ; note large spall with exposed rebar  
(7/10/2019)**

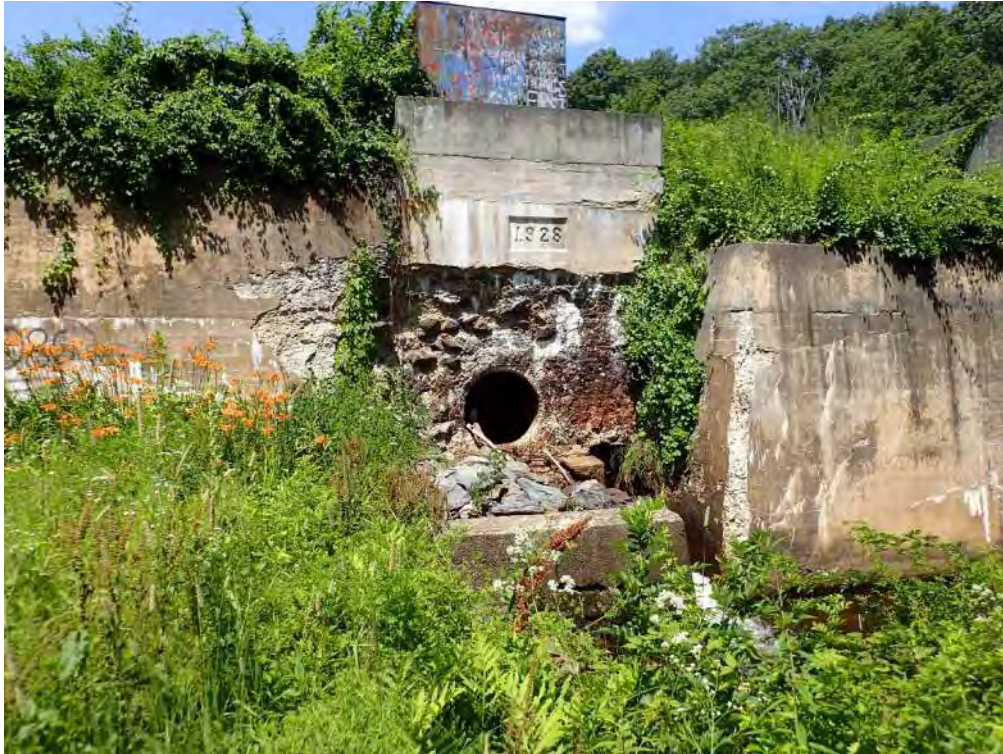
**Photo 27 – Deteriorated outlet structure; note missing facing concrete (7/10/2019)**

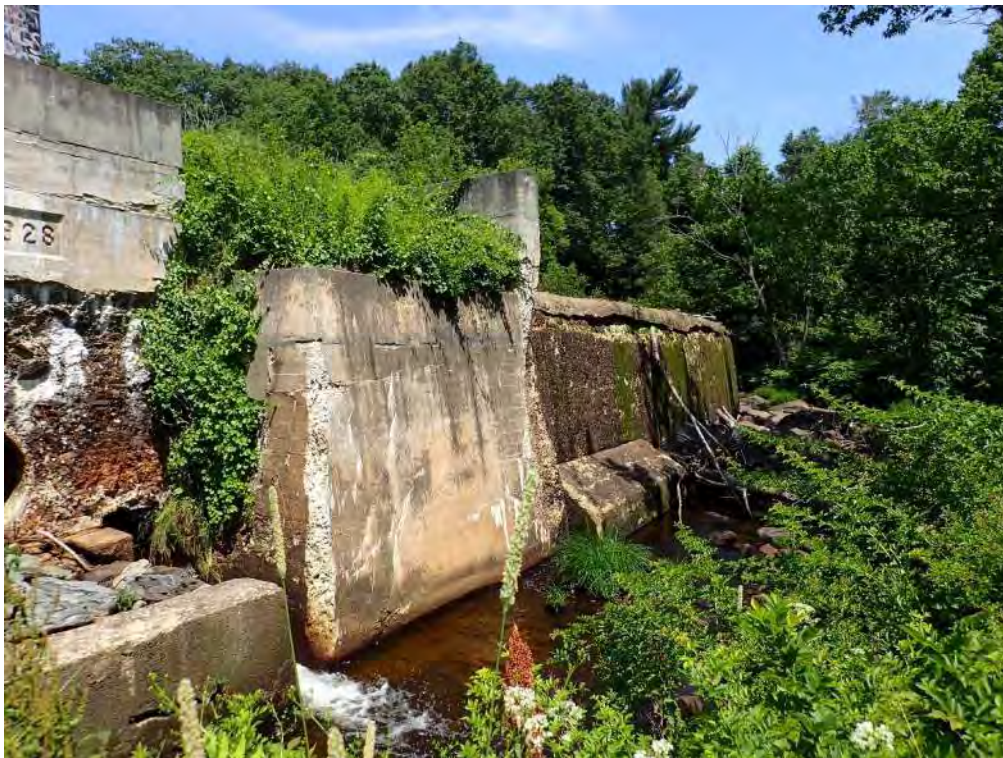
**Photo 28 – Overview of downstream side of spillway at right walls; note deteriorated concrete and gap along crest (7/10/2019)**

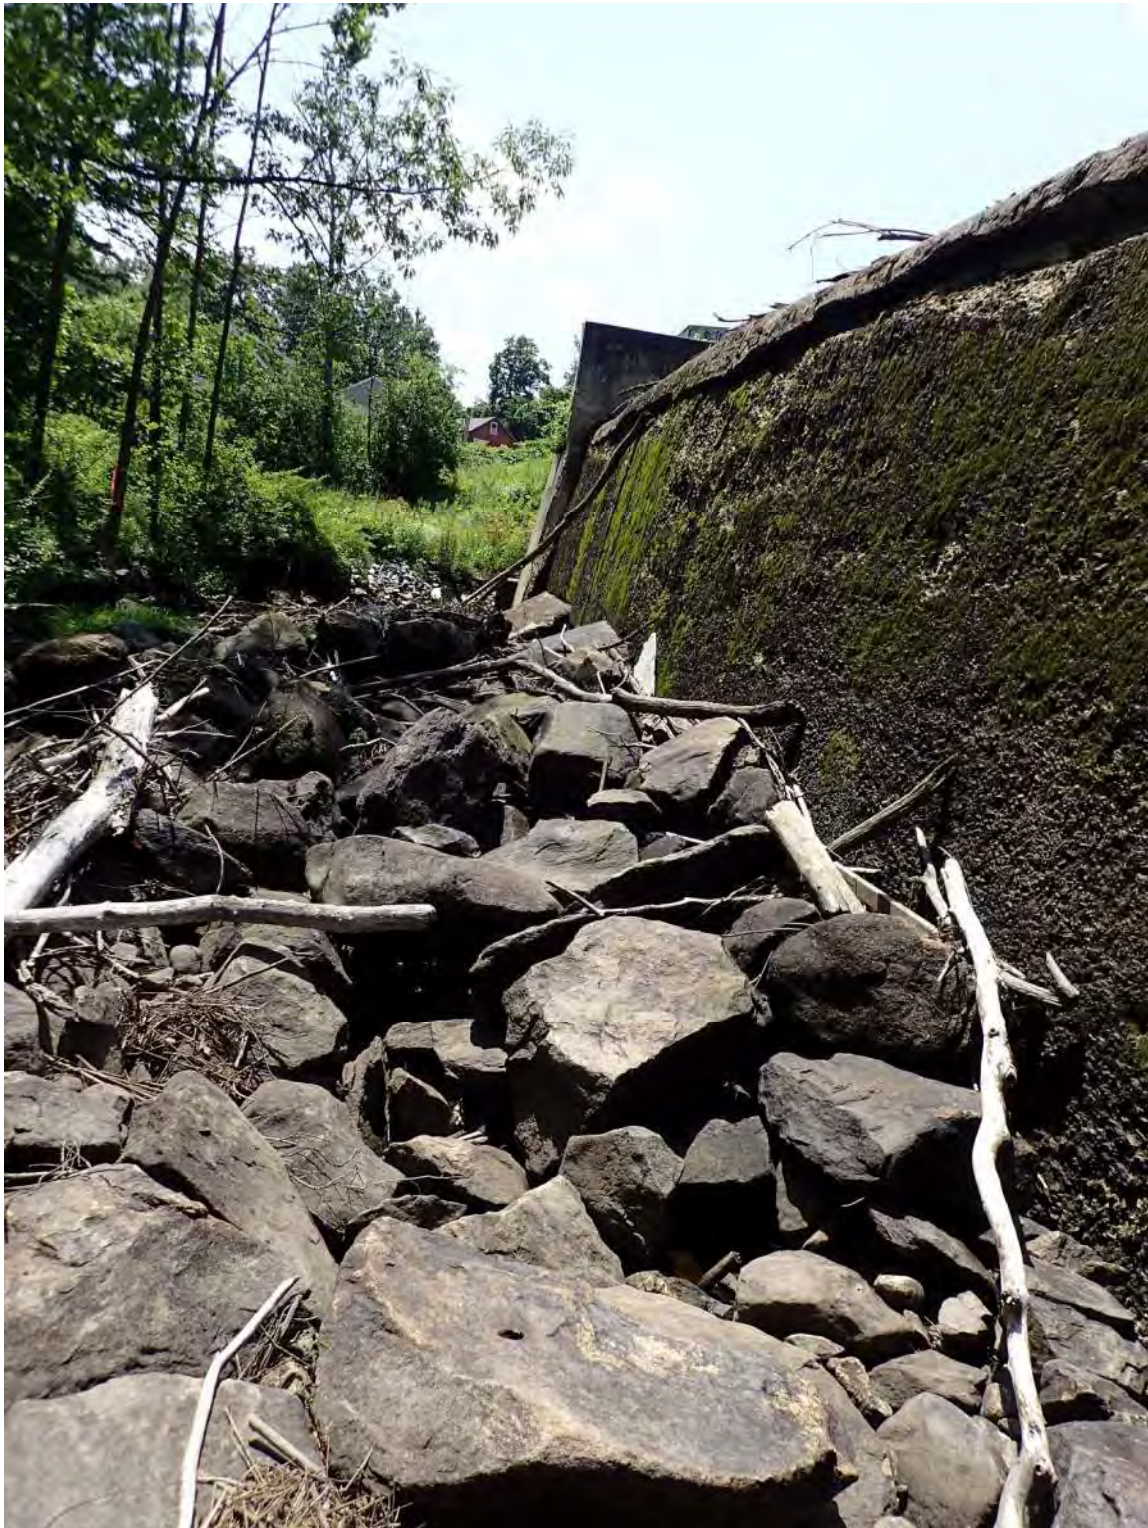
**Photo 29 – Right portion of spillway looking right; note wear on face and gap at crest (7/10/2019)**

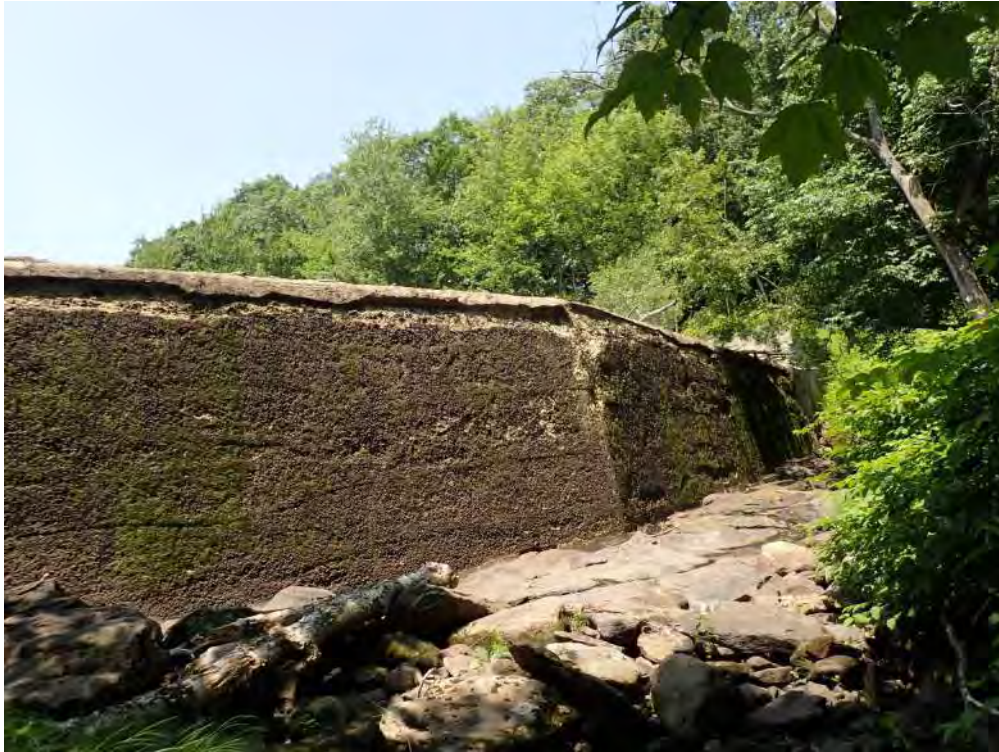
**Photo 30 – Center portion of downstream face of spillway looking left; note wear on face and gap at crest (7/10/2019)**

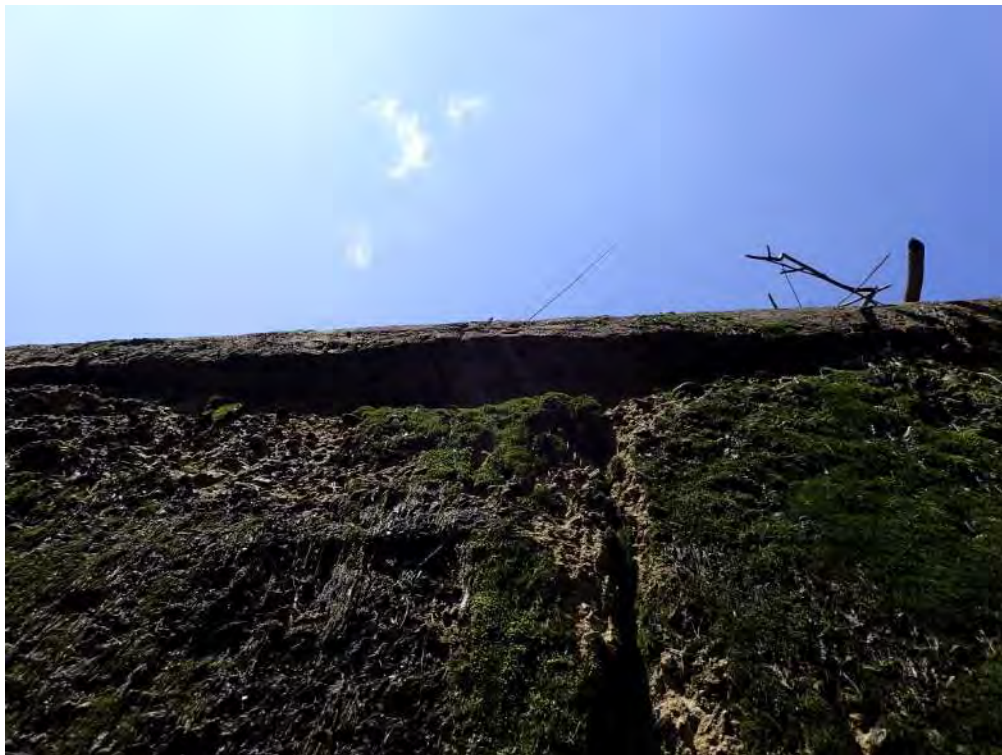
**Photo 31 – Gap below crest of spillway and wear at apparent joint (7/10/2019)**

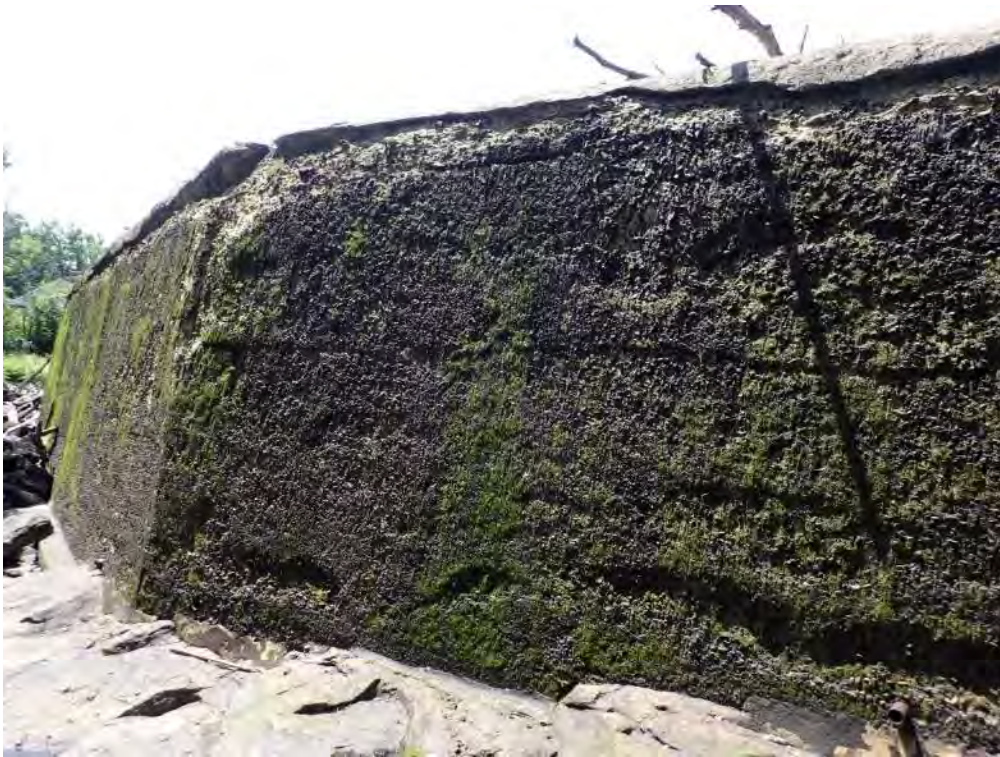
**Photo 32 – Center portion of downstream face of spillway looking right; note wear on face, gap at crest, and spalls (7/10/2019)**

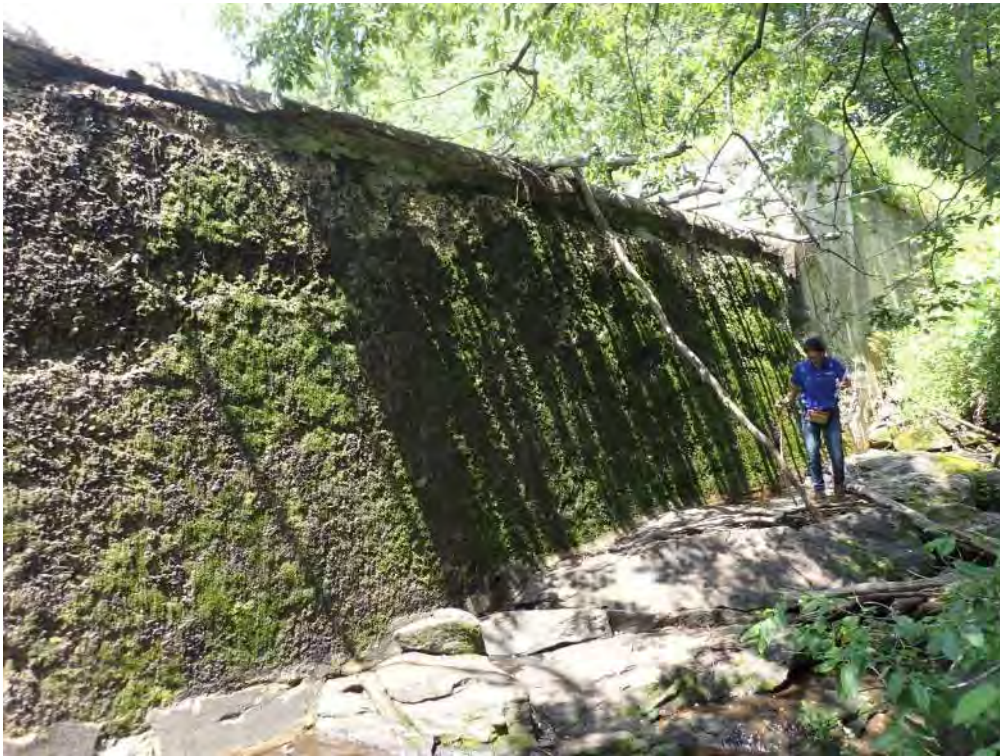
**Photo 33 – Left portion of downstream face of spillway looking left; note wear on face and gap at crest (7/10/2019)**

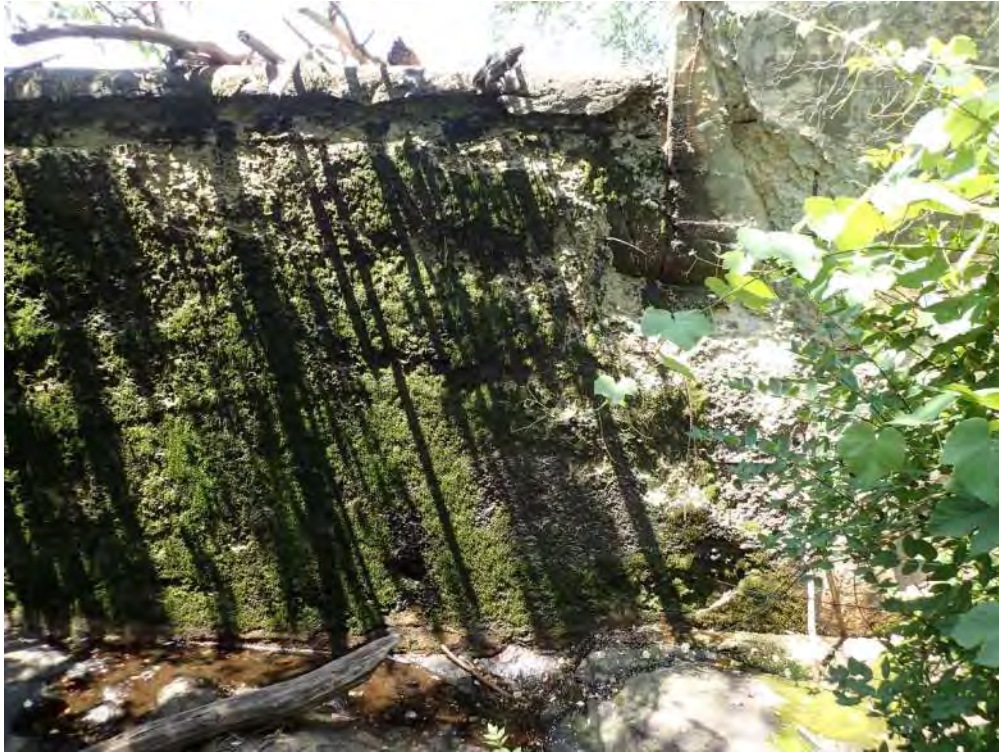
**Photo 34 – Downstream face of spillway at right training wall; note large spall and heavy wear (7/10/2019)**

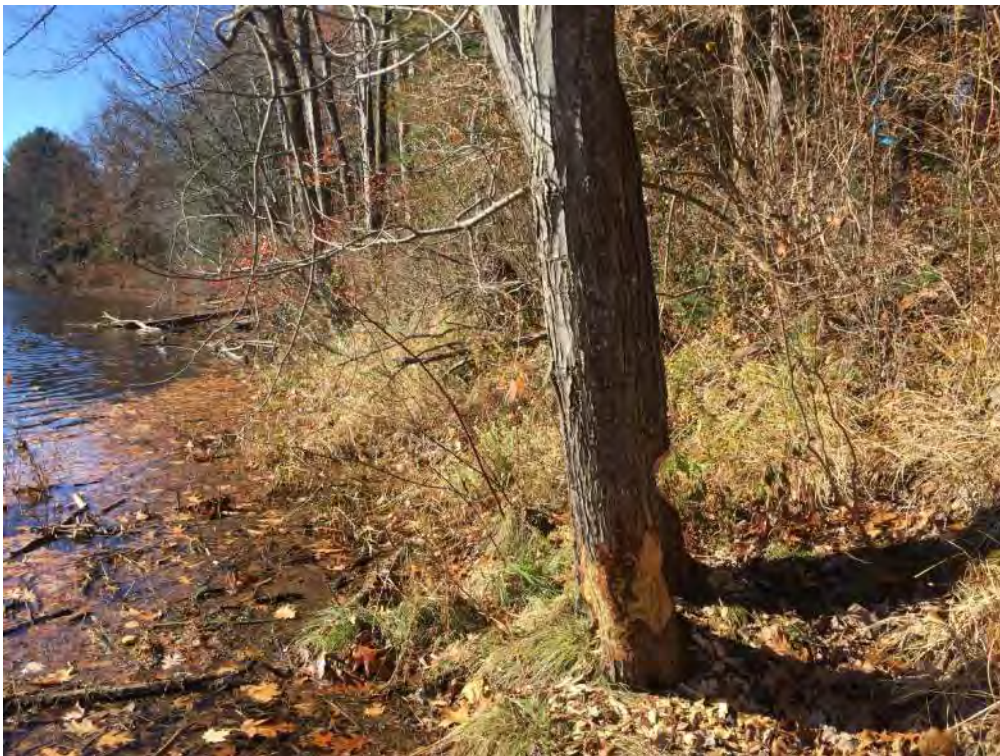
**Photo 37 – Northerly shore of pond; note signs of beaver activity (11/8/2018)**
